Analysis and characterization of PV module defects by thermographic inspection

S. Gallardo, L. Hernández and O. Duque, "Analysis and characterization of PV module defects by thermographic inspection", *Revista Facultad de Ingeniería Universidad de Antioquia*, no. 93, pp. 92-104, Oct-Dec 2019. [Online]. Available: <https://www.doi.org/10.17533/udea.redin.20190517>

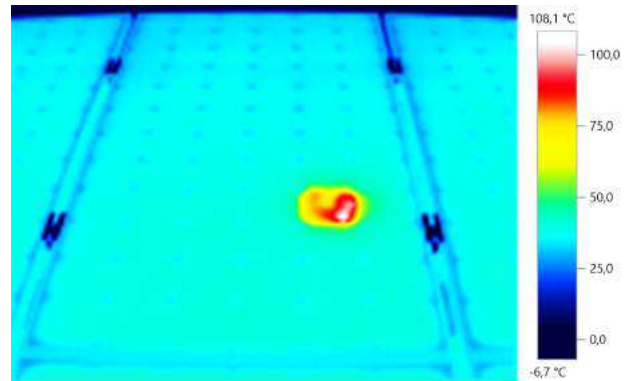
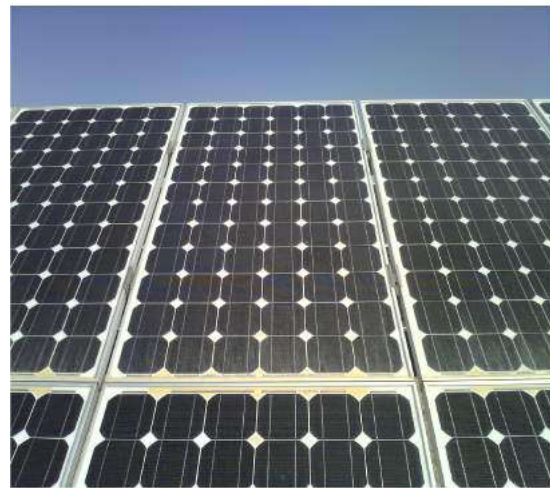
Reviewing all cells hotspot defects, it has been concluded that the pattern of this fault is an overheated cell, of approximate $15 \times 15 \text{ cm}^2$ depending on the module manufacturer, located in any cell along the module. The analysis performed does not reveal any preference of appearance of the overheated cell in any of the three strings circuits. The following figure, Figure 7, presents the ΔT of each of the 859 cell hotspots detected in the inspection in descending ΔT order, obtaining an average temperature of 12.4°C with a standard deviation on 12.8°C . Other relevant statistical values are the median, 7.4°C , and the first and third quartile, 3.8°C and 17.8°C , respectively. As it can be seen in Figure 7, the highest ΔT detected in the tests is 77.4°C , which supposes a cell hotspot

Figure 4 Hotspot located in the third string of a module, with a ΔT of 71°C

temperature of over 130°C . Reaching high temperatures can generate a fire hazard. Authors in [38] determined that the maximum hot-spot temperature on rear surface of PV module reached to 347°C with bypass diode not turned ON condition.

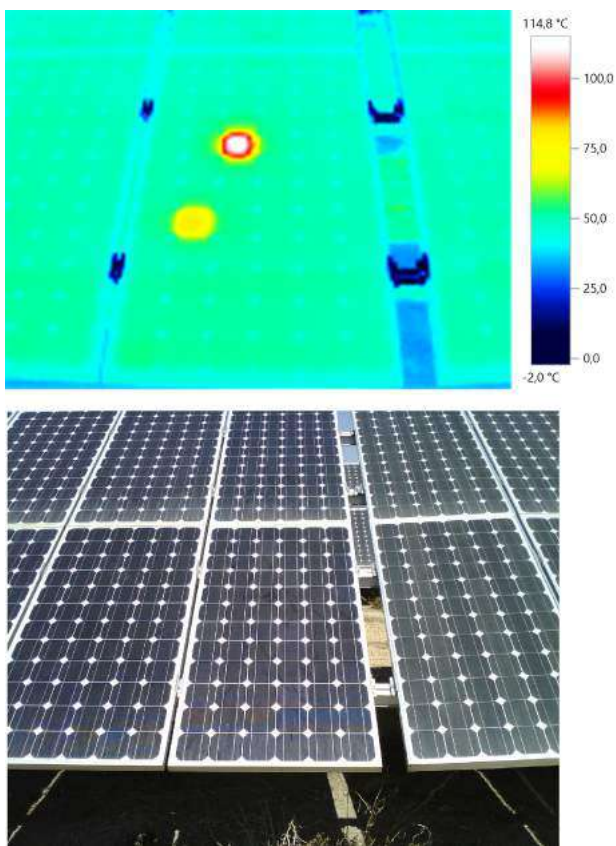
Figure 5 Two overheated cells within a module, one in the first bypass circuit and the most overheated in the second circuit, with a ΔT of 63.5°C

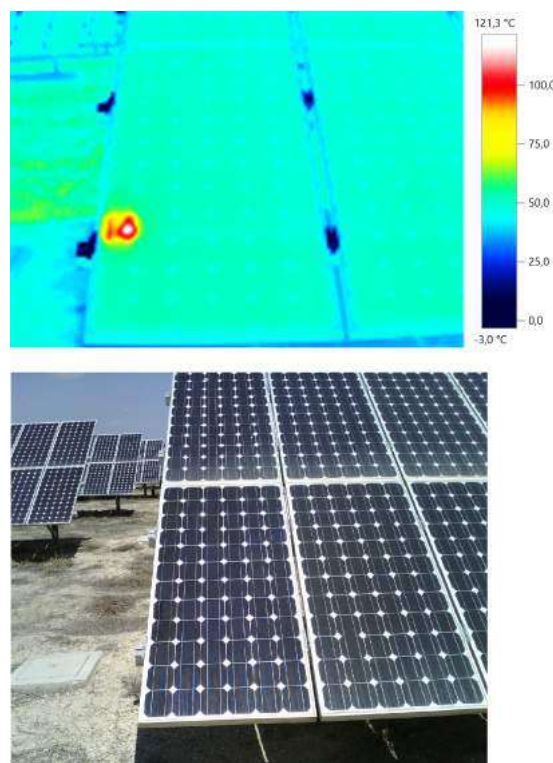
Figure 6 Overheated cell in the first bypass circuit next to the module frame, with a ΔT of 71.2°C

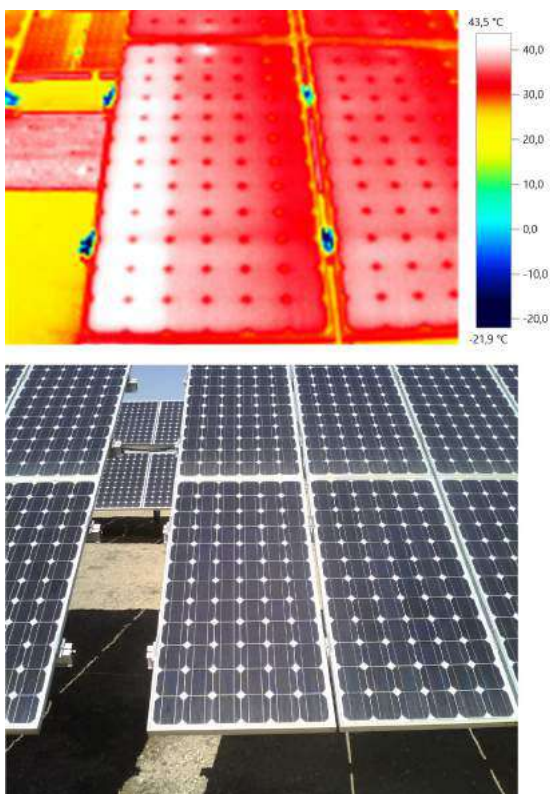
The thermographic and visual image of one bypass circuit overheated with a temperature difference of 5.7°C between the healthy area and the overheated bypass is presented in Figure 8.

Figure 8 Bypass circuit overheated with a ΔT of 5.7°C

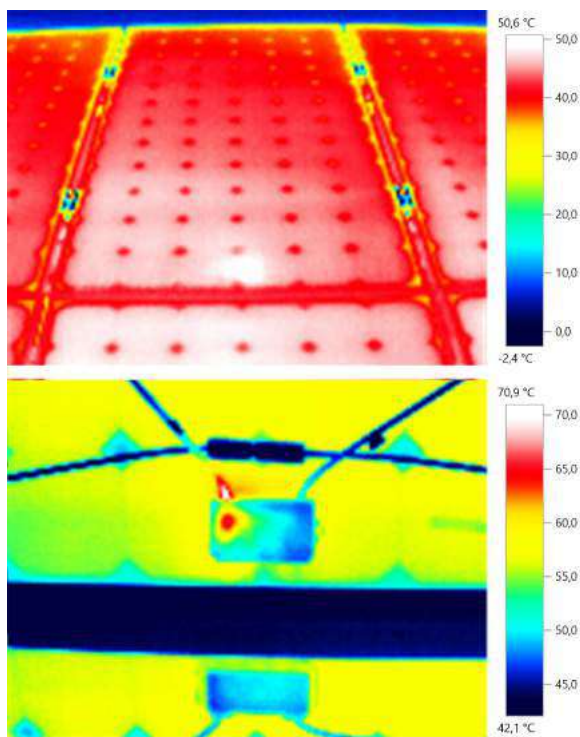
The main thermal abnormalities in that case are overheated bypass diodes, as the temperature of the diode when it is active is higher than the inactive diodes, reducing the power output of the module when the diodes are active. Two examples of overheat detected in the junction boxes are showed in Figure 11 and Figure 12 As it can be seen in the images, the defect is more pronounced in the back image than in the front, as the junction box is in the back and the difference measured in the front is only due to the heat transfer from conduction from the junction box. Therefore, to detect this kind of defects, it would be recommendable performing the inspection to the back of the modules; however, it is more complicated due to the PV structures tilt, as detailed before.

In relation with the pattern this kind of defects present, it has been shown that they are revealed as an overheated point in the middle part of the shorter side in which the box is located. This overheated point habitually appears in the middle of two different cells. In the PV plant in which the research has been performed, the modules of the upper row have the junction box underneath while the modules of the second row have the box in the upper part, as it can be seen in Figure 11 and Figure 12. The location of junction boxes along rows must be considered if a software must classify automatically the defects. The following figure, Figure 13, presents the ΔT of each of the 79 overheated junction boxes detected in the inspection in descencing ΔT order, obtaining an average temperature of 5.3°C with a standard deviation on 2.8°C. The maximum ΔT detected has been 15.6°C. Other relevant statistical values are the median, 5.6°C, and the first and third quartile, 3.3°C and

Figure 11 Front site of a module with a bypass diode overheated and of the junction box at the back of the module. ΔT is 6.7°C and 22.6°C respectively

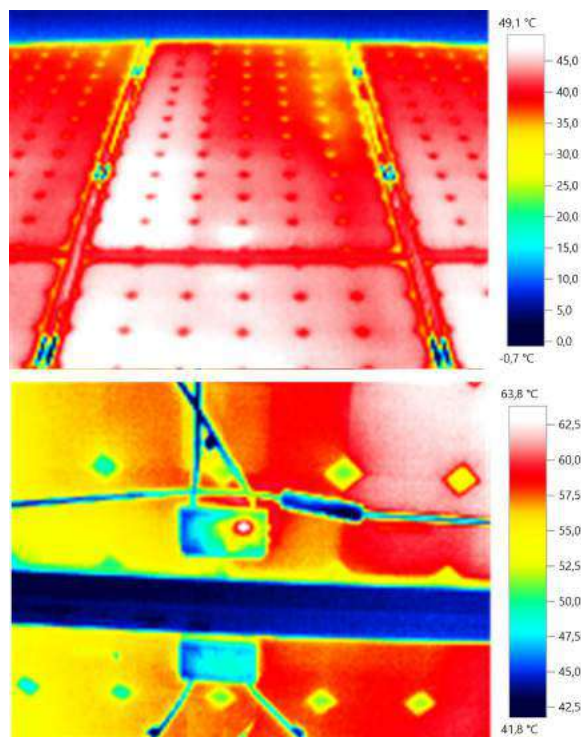
Figure 12 Front site of a module with a bypass diode overheated and of the junction box at the back of the module. ΔT is 9.3°C and 17.2°C respectively

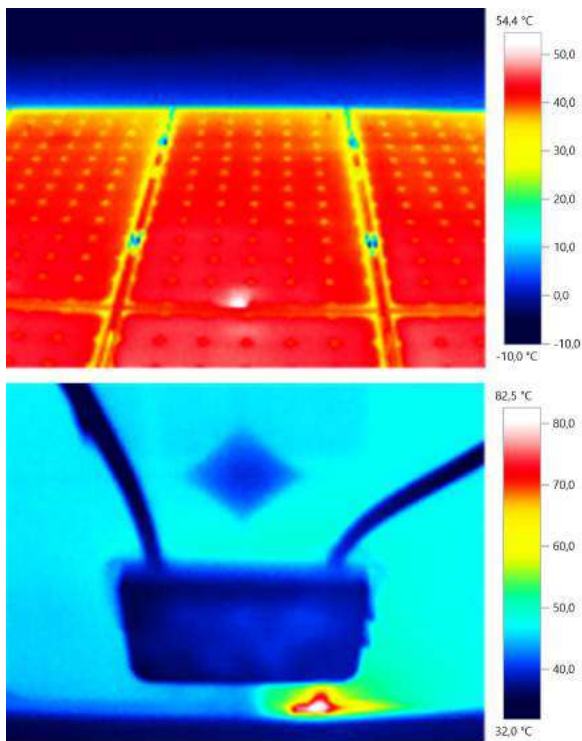
An example of an overheated connection found during the analysis is introduced in Figure 14. As it can be seen, the overheated area is not in the junction box, but in the connection between bus ribbon or bus wires and the box.

Reviewing all connection defects, it has been concluded that the pattern of this fault is an overheated point, generally smaller than a cell, located next to the frame in the same side in which the junction box is placed. The following figure, Figure 15, presents the ΔT of each of the 78 overheated connections detected in the inspection in descending ΔT order, obtaining an average temperature of 10.9°C with a standard deviation on 8.1°C. The maximum ΔT detected in this case has been 45.1°C. Other relevant statistical values are the median, 9.0°C, and the first and third quartile, 5.2°C and 13.8°C, respectively.

Figure 14 Overheated connection between the bus ribbon or bus wires and the junction box with a ΔT of 11.7°C and 35.8°C, at the front and back side respectively

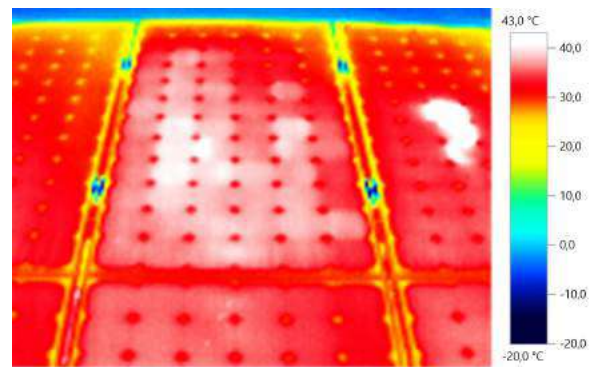
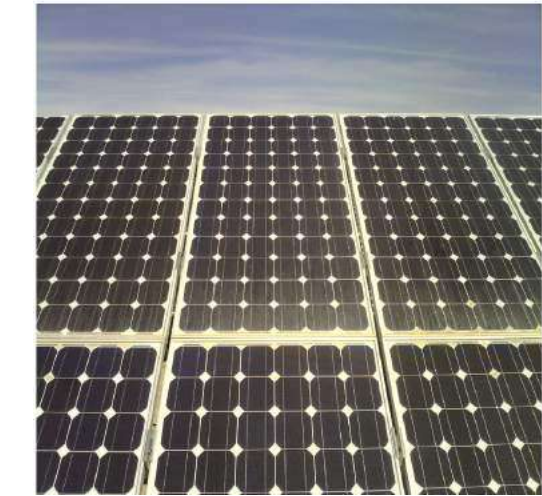
If one module or several modules connected in series have a higher temperature than the rest, the modules may not be connected to the system and the wiring should be checked. Figure 16 shows the only defect in the whole

module detected during the site inspection.

It has been noticed that differences in temperature between a module and the rest of modules of the same row or string could be due to an erroneous connection between them, mismatching or to internal defects of the module affecting all the bypass circuits. This kind of defect can be automatically detected as a difference of the mean temperature of one module with respect to the rest of the modules of the same PV structure.

Figure 16 Overheated module with a ΔT of 10.5°C between the mean temperature of the adjacent modules and the mean temperature of the overheated module surrounded in the figure
