A comparative surface analysis of explanted hip joint prostheses made of different biomedical alloys

Angela Bermúdez-Castañeda

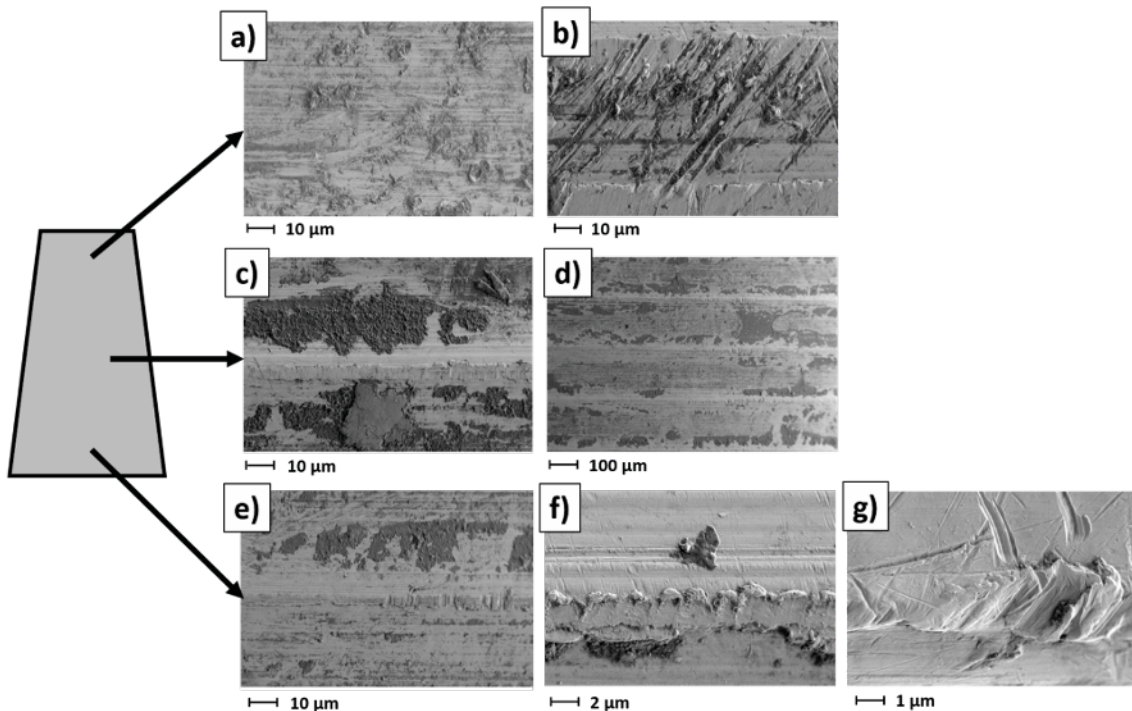
Some debris particles were observed around the deformed material Figure 3 **a)** - **b)**. Small movements could cause some particles to be trapped in the deformed area. As long as the ploughing generates surface stacking between modular parts, there is less movement, and the ejection of metallic or oxidized worn particles is less likely.

A detailed surface examination shows, deformation marks in the extraction and insertion direction were observed, as shown in Figure 3 **c)** - **d)**. In this respect, the distal area was the most affected in the areas shown in these images. Furthermore, ploughing on the fillets from the thread was observed Figure 3 **e)** - **g)**. In arthroplasty procedures, implant parts are assembled by hammering, in order to ensure a tougher fixation between the femoral head and the trunnion. This action produced ploughing in the fillets of the trunnion thread pattern, which suggests an effective stuck phenomenon in the distal area.

Images from the middle part of the trunnion show ploughing, although to a less severe degree than in the distal area. Moreover, some particles of organic material (biofilms), which composition is shown in Table 3 and Figure 4, can be found at this distance, as shown in Figure 3 **d)**. The entry of this material shows that even if the obstruction is produced at the entrance, material and particles can pass through the length of the trunnion.

Figure 3 SEM images of a Ti6Al4V trunnion from hip explant. Proximal part a) 500x, b) 1000x; medium part c)500 x, d) 100x; distal part e) 500x, f) 3000x, g) 5000x

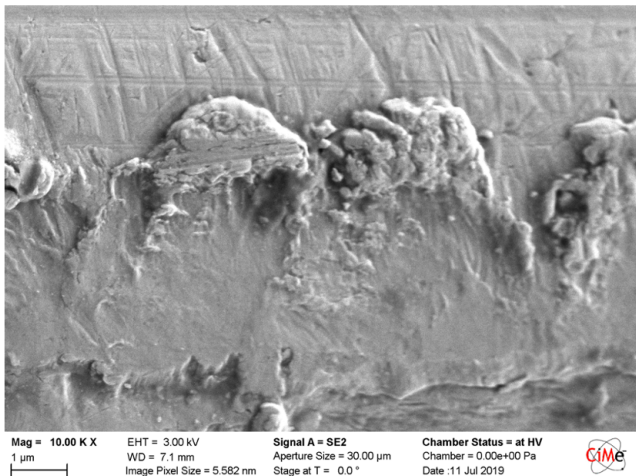
Furthermore, a closer observation of the smeared areas in Figure 5 shows no cracks or their propagation in distal zones.

Figure 5 Ploughing found in fillets on the thread patterns in Ti6Al4V trunnion in the distal area. Image amplification 10000x

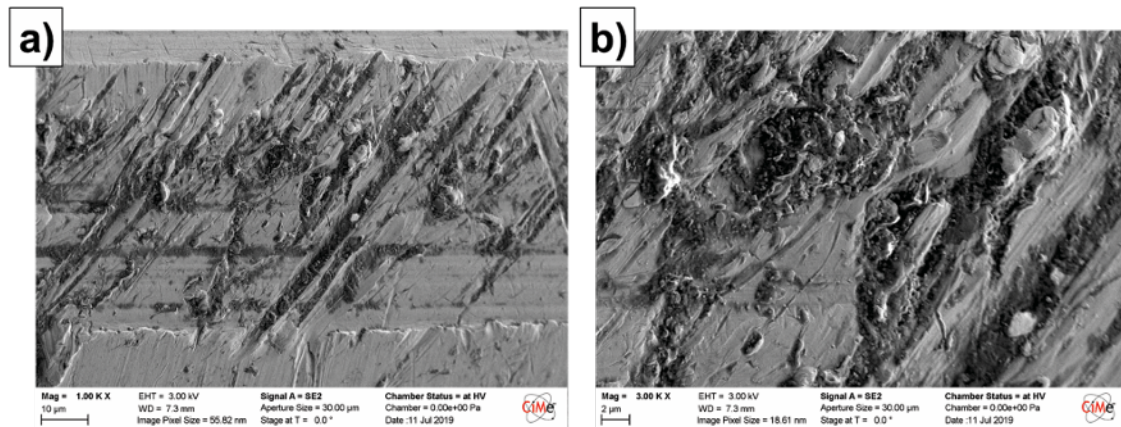
Some differences in material wear were found in the proximal part with respect to the rest of the implant. Nonetheless, ploughing is observed in the thread. Tracks, abrasion lines, and debris particles were also found in the thinner part of the cone, as observed in Figure 6 **a)** - **b)**. Those findings suggest that more micro-movements were generated in this area, due to the higher wear produced by the fretting mechanism.

Figure 6 Wear and debris particles found on Ti6Al4V trunnion surface in the proximal zone. Image amplification a) 1000x and b) 3000x

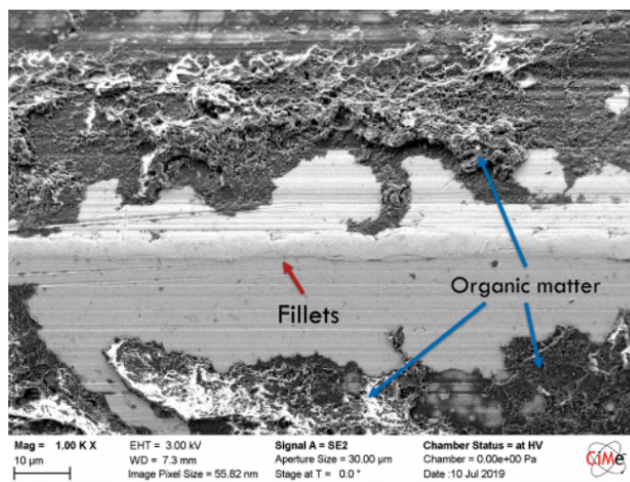
made in the revision procedure. Furthermore, higher hardness, according to Table 1, can explain the lower plastic deformation found (fillet in Figure 8). Moreover, the

high dislocation density (produced during fillet machining) could explain the brittle failures observed.

Figure 8 Biofilm and fillets identified in the proximal part of the trunnion

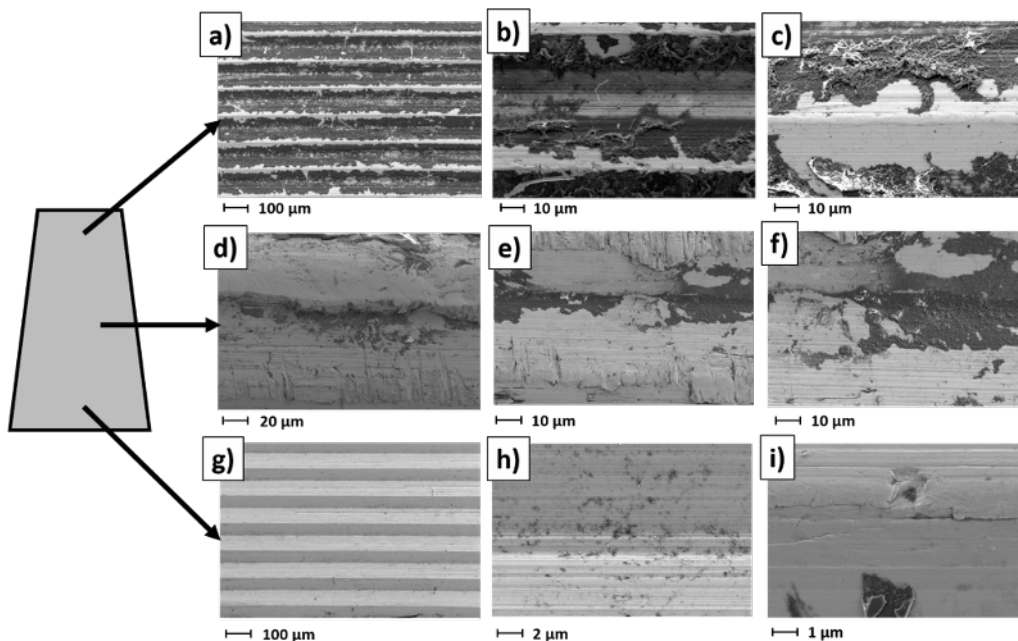
Although the femoral head has a thread pattern to enhance fixation, no significant deformations were observed in the CoCr trunnion as it was observed for titanium alloy explant. This explanted prosthesis shows a large amount of biofilms deposits on the thread pattern fillets in the proximal part (as corroborated by EDX in Table 4). That suggests a free entry of organic matter and its easy deposition in the proximal zone (Figure 8 **a)**, **b)**, and **c)**, suggesting a poor stuck between the trunnion and the femoral head with a mismatch angle as A. Ashkanfar *et al.* [23] found. Although previous studies (Su *et al.* [24]) indicate that those deposits are mainly corrosion products, the EDX spectra of the CoCr trunnion analyzed in this study do not show oxygen content. In contrast, carbon content was observed, which suggests that they may correspond to biofilms (Table 4) where the amount of metallic material is more significant. In addition to those layers, deformation lines, such as scratches, as well as detached material in the direction of the insertion and extraction processes (Figure 9 **d)**, **e)** and **i)** were found in the distal part, and especially in the middle part.

Compared to the titanium alloys prostheses, the deformation level of the thread patterns is lower, and some brittle failures were identified (Figure 9 - 5kX). The latter probably formed during the remotion of the head

Figure 9 SEM images of a CoCr trunnion from hip explant. Proximal part a) 100x, b) 500x, c) 1000x; medium part d) 500x, e) 500x, f) 1000x; distal part g) 100x, h) 3000x, i) 5000x

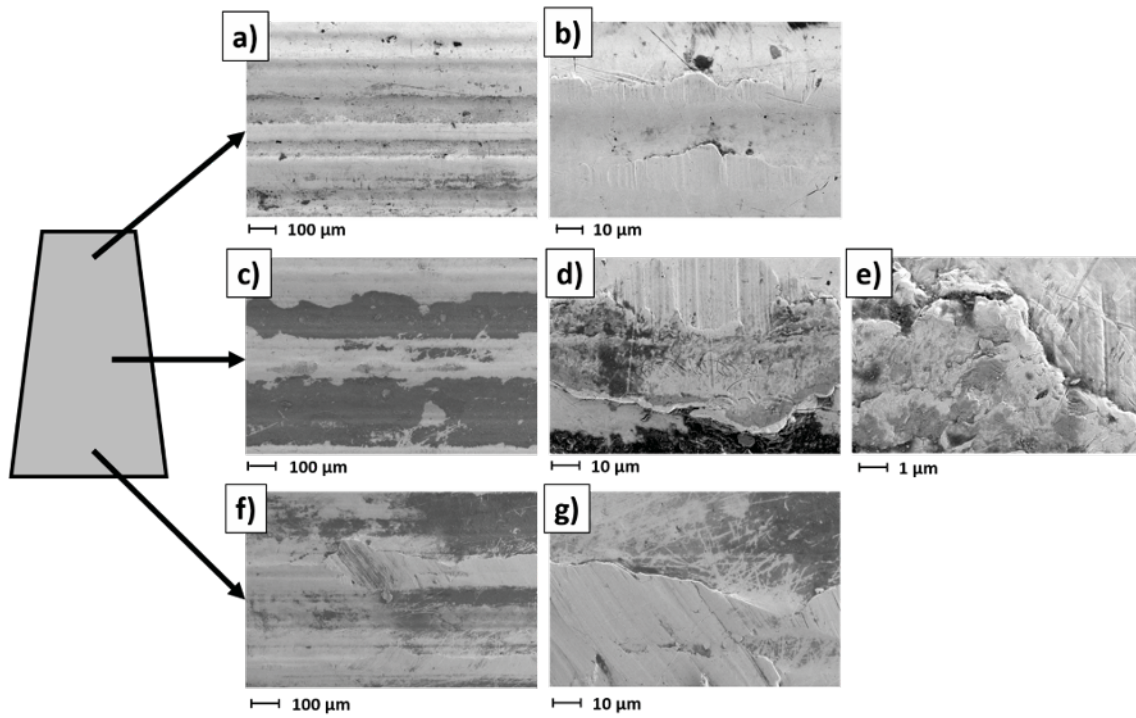
The explanted stainless-steel trunnion, as well as the Ti-6Al-4V and CoCr prostheses, are subjected to surface texturization to promote adhesion, as can be seen in Figure 10 **a)** and **c)**. The chemical composition by EDX is shown in Table 5, the spectrum shown in Figure 11. SEM images of each part of the trunnion are shown in Figure 10. The distal part exhibits a higher intensity of damage than the proximal part.

Figure 10 SEM images of a stainless-steel trunnion from hip explant. Proximal part a) 100x, b) 500x; medium part c) 100 x, d) 1000x, e) 5000x; distal part f) 100x, g) 500x

abrasive performance was observed on the part of the stainless-steel particles rolling in the contact, as shown in Figure 10, which can be explained by the hardness of the material. Once the particle is detached, reincorporating it into the material in the contact can be more difficult compared to what was observed for titanium particles.

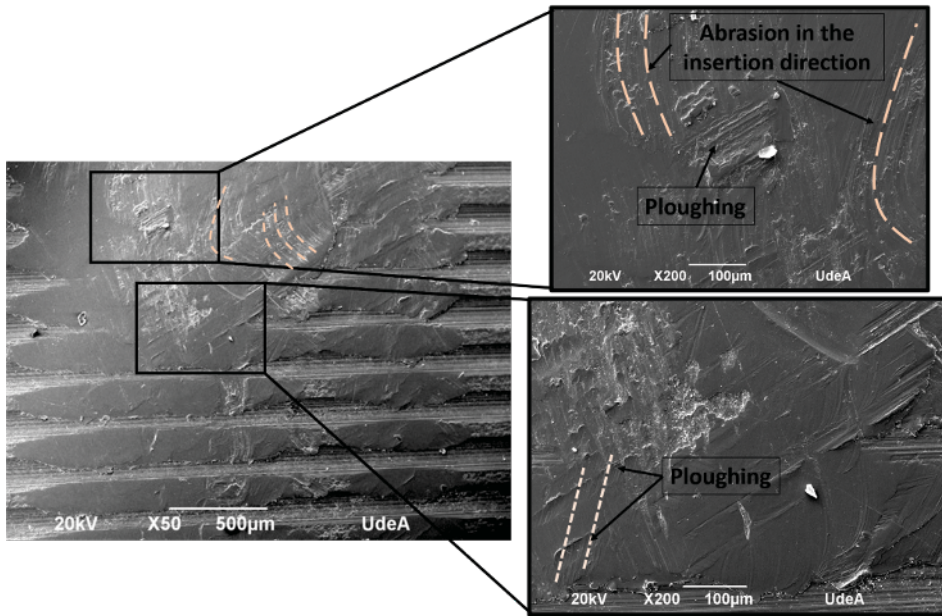
of the trunnion and along the direction of insertion and extraction, as well as ploughing in the perpendicular direction of insertion. This is observed in Figure 12. As mentioned, this wear was much lower compared to examined prostheses made of CoCr and Ti6Al4V, which could possibly be explained by the stainless-steel hardness (Table 1). However, there is a significant difference in the damage caused with respect to the Ti-6Al-4V prosthesis as, rather than deformed particles; detached particles are observed that are smeared inside the contact and rolled on the surface, creating an abrasive phenomenon, as shown in Figure 13.

Figure 12 Wear mechanisms found in 316L SS trunnion surface

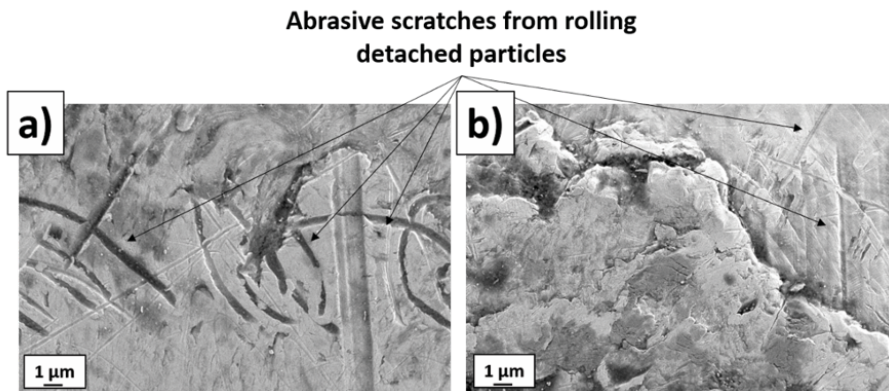
Figure 13 Stainless-steel hip explant degradation, a) 500X and b) 5000X

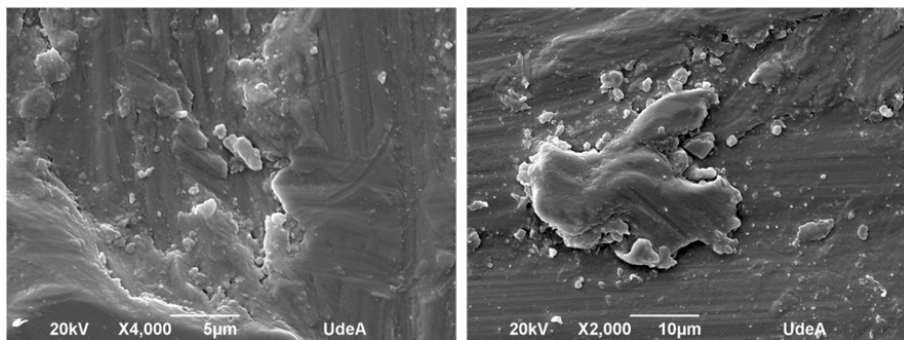
Detached particles can be observed in Figure 14. These particles have the same chemical composition as the SS prosthesis. Moreover, no oxygen is observed, which indicates the presence of metallic material. In addition, EDX analysis in Figure 15 shows a material layer formed on the material surface similar to those reported in previous studies [16, 25], [26]. These films, known as a tribofilm, are formed by the oxidized and metallic material worn from both interfaces in contact. The layer was found on the explanted trunnion of 316L stainless steel, which was paired against a Co-Cr alloy head. The alloy contains an average of 18.55% of Cr, according to EDX (see Table 5 and Figure 11). However, the chemical analysis of the surface

Figure 14 Detached particles and their chemical composition in SS trunnion surface

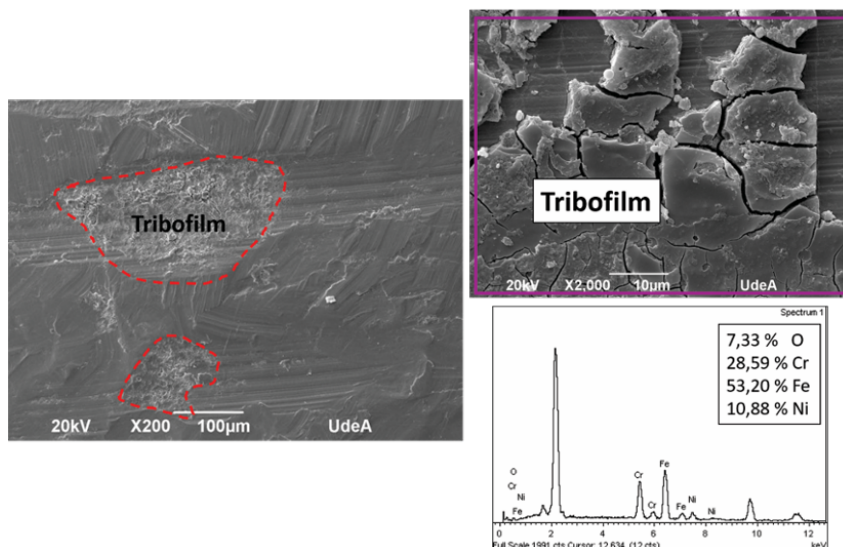
covered by organic material exhibits higher contents of Cr, of 28.51 %, as well as oxygen contents of 7.33 % (Figure 15). This chromium excess and oxygen could indicate fretting corrosion in this system, with material transfer from the Co-Cr alloy to the SS trunnion.

Figure 15 Detail of the tribofilm material found in the surface of the SS trunnion

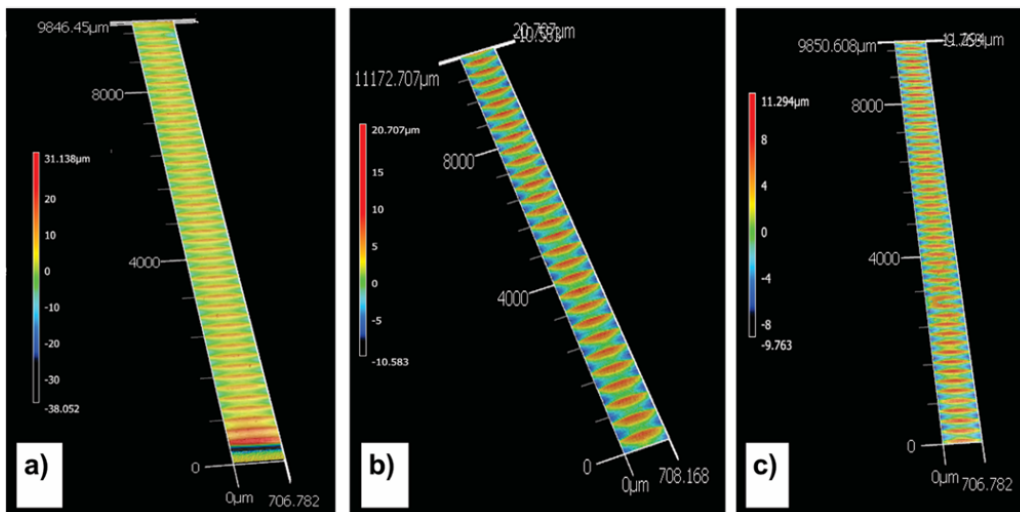
the trunnion length are taken by the confocal and laser microscope and are assembled in order to examine the trunnion extension. The most deformed areas are colored in red. As observed, bigger red zones were localized in the distal than in the middle and proximal region.

Consistent with previous observations in titanium alloy trunnions, the 3D map shows a more extended degradation area in the distal part compared to the proximal part (Figure 16 **a**). For the stainless-steel

trunnion, although a difference along the trunnion is observed between proximal and distal zones, it is not as pronounced as in the case of the titanium alloys, as shown in Figure 16 **c**). Finally, the 3D map taken of the CoCr trunnion shows no significant difference between the distal and the proximal part, as was found in the examination done by SEM.

Figure 16 Optic profilometry of the explanted a) Ti6Al4V, b) CoCr, and c) SS trunnion surface
