# Flaw recognition in reinforced concrete bridges using infrared thermography: A case study

Joaquín Humberto Aquino-Rocha

### 3. Analysis and discussion of results

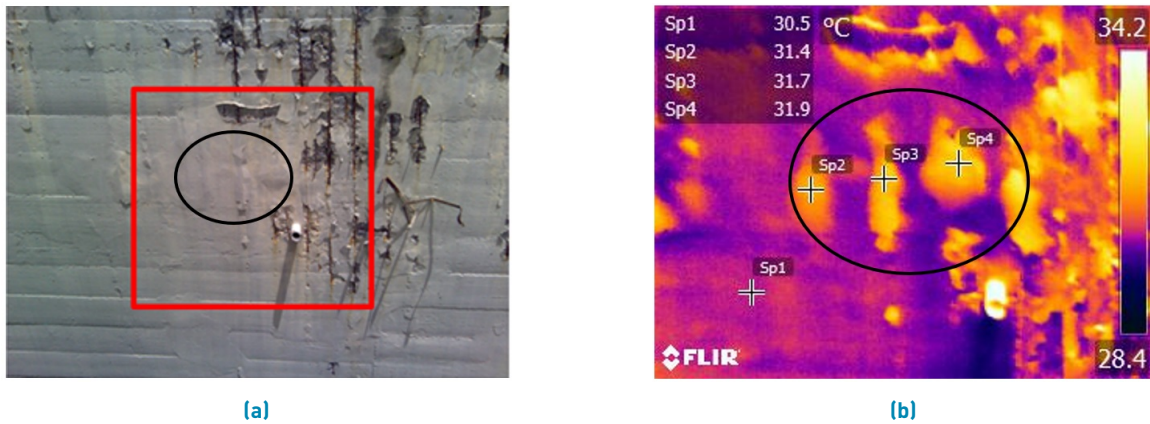
Figure 2a shows a portion of the superstructure close to the main slab of the Duarte Coelho bridge. This section was exposed to the sun in a northern direction (N) where detached areas and exposed steel are observed. However, Figure 2b shows three hot areas not visible in the digital image. This shows temperature differences of 0.9 °C (Sp2-Sp1), 1.2 °C (Sp3-Sp1) and 1.4 °C (Sp4-Sp1). Also, it indicates the presence of defects internal in concrete, such as delamination and voids. These problems are presented as sectors of higher temperature in relation to intact concrete when exposed to the sun [12, 30]. The thermogram is included within the red frame of the digital image. The yellow colors represent high temperatures, while the colors in purple tones lower temperatures.

**Figure 2** Superstructure of the Duarte Coelho bridge: a) Digital image and b) Thermogram. Source: The Authors

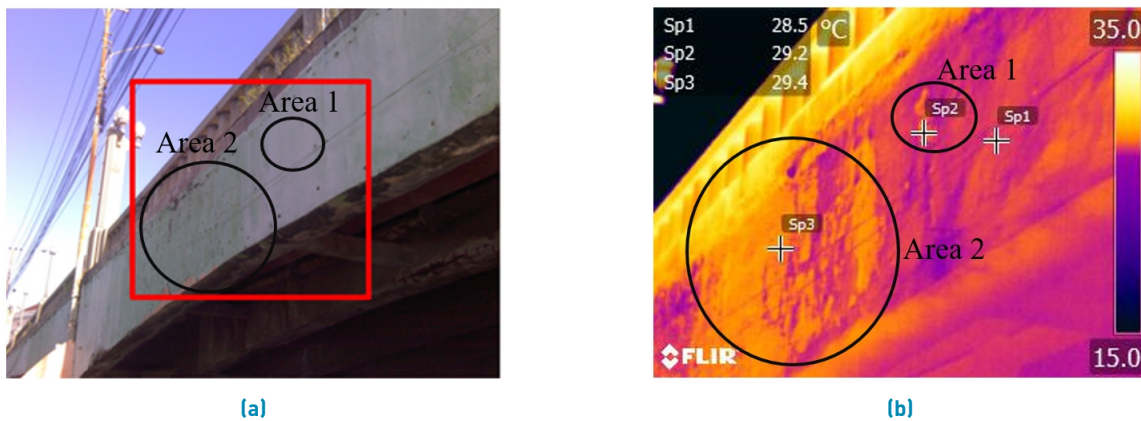
Figure 3b presents the thermogram of the beams of the Princesa Isabel bridge in a northern direction (N), where a small hot area (Area 1) is observed. This area may represent a surface problem in the concrete with a thermal difference of 0.7 °C (Sp2 -Sp1). Larger hot areas (Area 2) with temperature differences of 0.9 °C (Sp3-Sp1) can also be observed in the same thermogram; however, they are not considered as delaminations or defects. As can be seen in Figure 3a, these regions depict the wearing and peeling of the paint on the concrete. The latter allowed the development of irregularities in the surface temperature in this stretch.

**Figure 3** Superstructure of Princesa Isabel bridge: a) Digital image and b) Thermogram. Source: The Authors

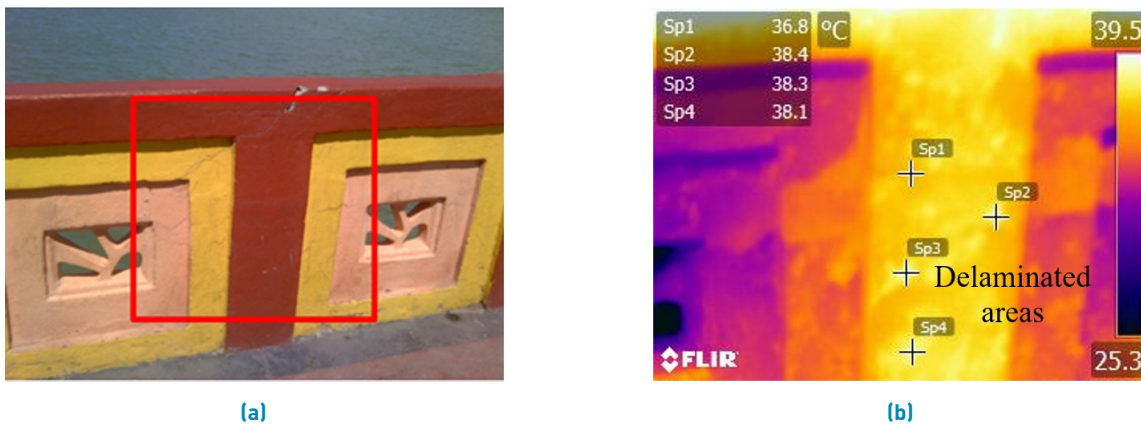
Figure 4a presents the parapet of the Maurício de Nassau bridge exposed to direct sunlight in a northern direction (N). Here, no visible defects are observed, due to some repairs made and the new coat of paint. However, Figure 4b shows several delaminated areas. These areas are depicted as hot areas because of the sun exposure that warms the areas above the delaminations faster than the

areas without defects [10, 12]. The measured temperature differences are greater than 1 °C at the points analyzed: 1.6 °C (Sp2-Sp1), 1.5 °C (Sp3-Sp1) and 1.3 °C (Sp4-Sp1).

**Figure 4** Concrete parapet of the Maurício de Nassau bridge: a) Digital image and b) Thermogram. Source: The Authors

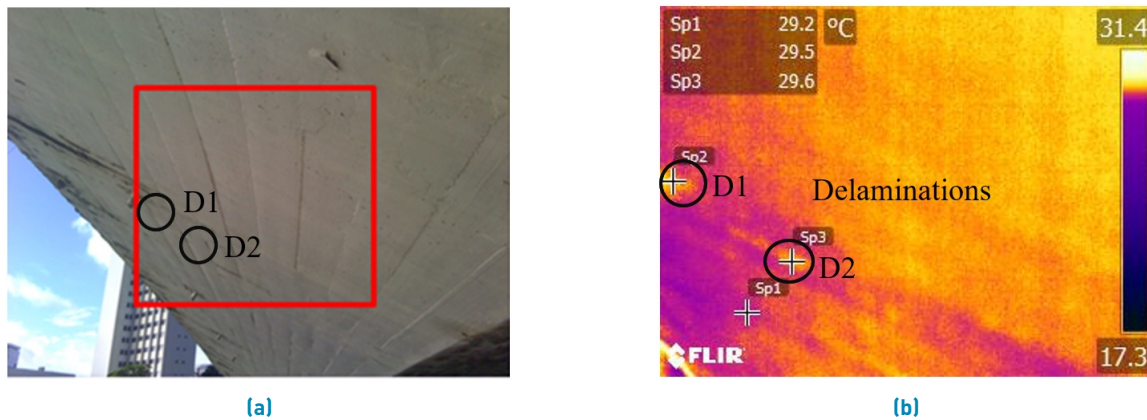
Figure 5a presents the digital image of the surface exposed to the sun from the superstructure of the Giratória bridge. The transverse section of the bridge is composed of a prestressed concrete cell box in a northeast direction (NE), in which no apparent damage was observed. However, the thermogram illustrated in Figure 5b shows two thermal gradients on the concrete surface, indicating defects or internal delaminations. Although the temperature differences are insignificant, 0.3 °C (Sp2-Sp1) and 0.4 °C (Sp3-Sp1).

Figure 5 Giratória bridge: a) Digital image and b) Thermogram. Source: The Authors

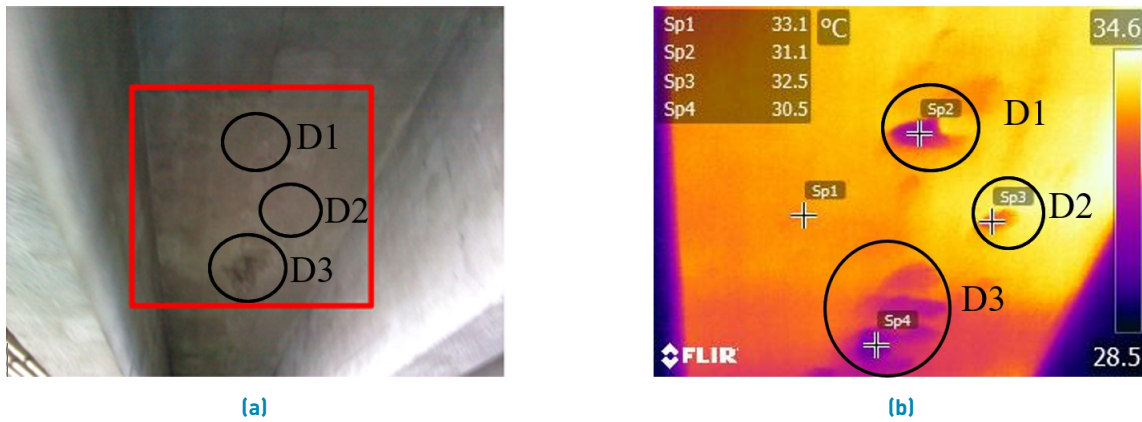
Figure 8a and Figure 9a show the slab and beams of the Duarte Coelho bridge infrastructure where signs of previous repairments can be seen. Figure 8a shows a damaged area with exposed steel; this can also be detected in Figure 8b. In addition, other invisible areas

in the digital images are depicted, indicating that the detached and delaminated areas have been covered. The latter appear as colder sectors in the thermograms; this situation is due to the gradient of temperature existing inside the slab. However, the defects interfere with the heating of the areas below themselves, presenting as negative gradients or cold spots. The hotter areas

indicate intact areas without defects. Because they allow heat transfer without interference. The temperature variations are  $-2.0\text{ }^{\circ}\text{C}$  (Sp2-Sp1),  $-0.6\text{ }^{\circ}\text{C}$  (Sp3-Sp1), and  $-2.6\text{ }^{\circ}\text{C}$  (Sp4-Sp1). In the thermogram of Figure 9b, the differences are  $-1.5\text{ }^{\circ}\text{C}$  (Sp2-Sp1) and  $-1.6\text{ }^{\circ}\text{C}$  (Sp3-Sp1).

**Figure 8** Duarte Coelho bridge infrastructure 1: a) Digital image and b) Thermogram. Source: The Authors

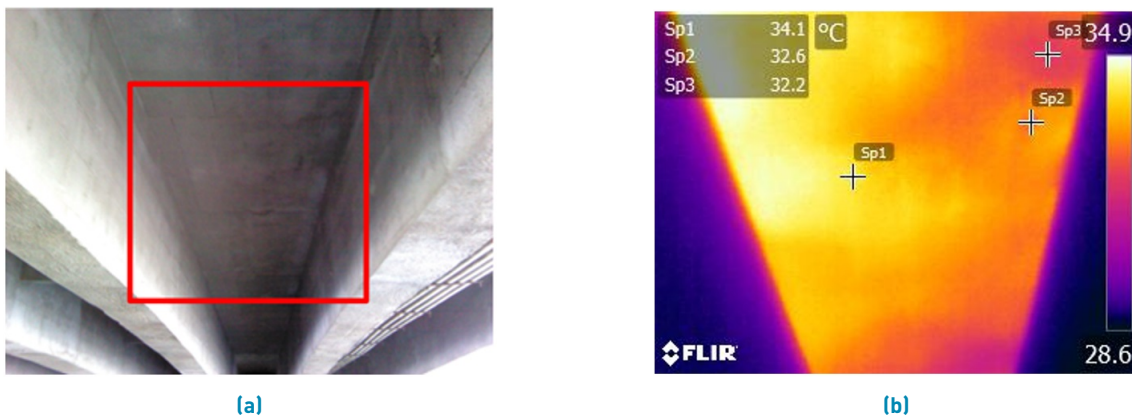
**Figure 9** Duarte Coelho bridge infrastructure 2: a) Digital image and b) Thermogram. Source: The Authors

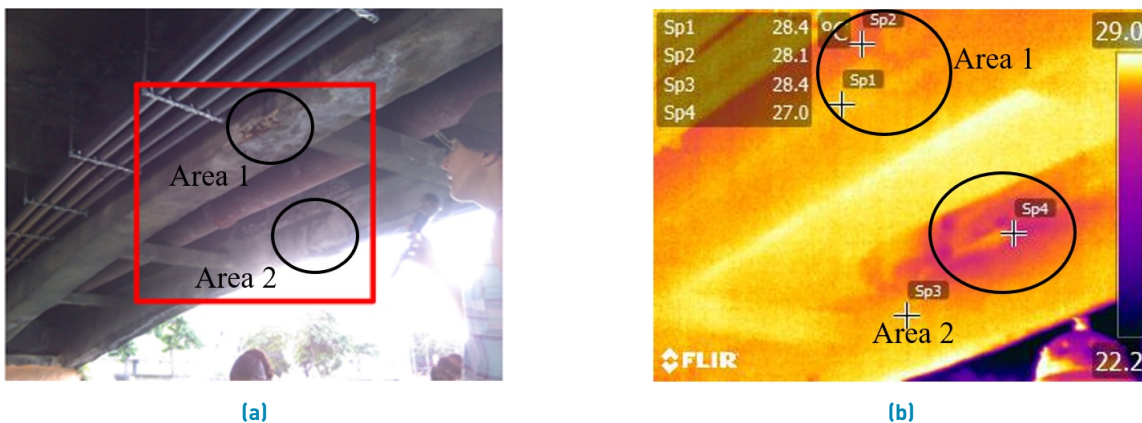
Figure 10a presents the beams of the Princesa Isabel bridge in the infrastructure area. Two damaged areas were observed: Area 1 displays an evident deterioration, but in the thermogram of Figure 10b, there are no significant variations in temperature,  $-0.3\text{ }^{\circ}\text{C}$  (Sp2-Sp1). This indicates that this area is not delaminated or at risk of detachment. Nonetheless, this may be a sign

of localized corrosion; thus, the concrete has already detached. Area 2 also shows deterioration and detached parts with exposed steel. The thermal image shows a larger cold area,  $-1.4\text{ }^{\circ}\text{C}$  (Sp4-Sp3), indicating generalized corrosion and regions at risk of being detached. As the areas are in the infrastructure, there is no direct solar radiation; thus, there is a cold environment in relation to the superstructure. The delaminated and detached regions balance more rapidly with the environment than other areas, which need more time to achieve this equilibrium.

**Figure 10** Infrastructure of Princesa Isabel bridge: a) Digital image and b) Thermogram. Source: The Authors

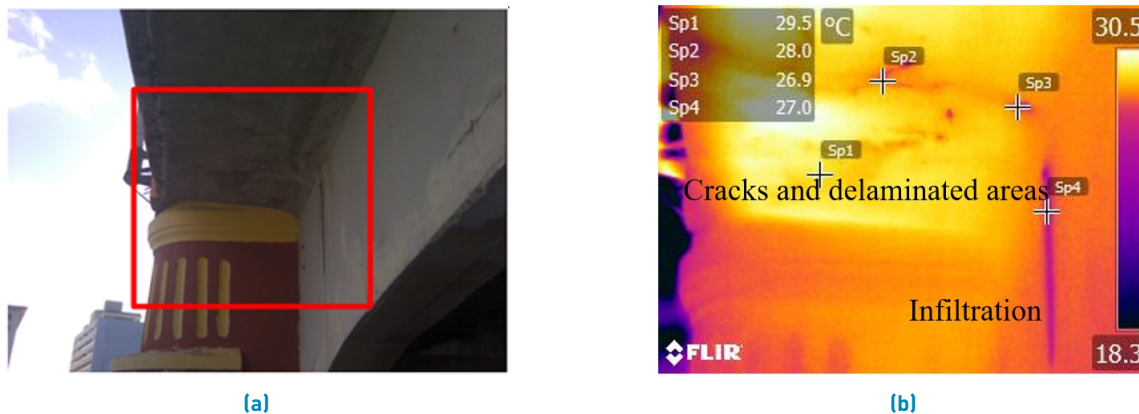
the support pier of the Buarque de Macedo bridge. This sector has no sun exposure because it is in the south (S) direction. It is observed in Figure 11b that the cracks and the delaminated areas are presented as cold in relation to the intact concrete that has a higher temperature. The latter can be verified in the temperature variation between different points of the structural element,  $-1.5$

$^{\circ}\text{C}$  (Sp2-Sp1) and  $-2.6$   $^{\circ}\text{C}$  (Sp3-Sp1). In addition, the infiltration located in the beam wall is cold due to the presence of water with a temperature difference of  $-2.5$   $^{\circ}\text{C}$  (Sp4-Sp1).

**Figure 11** Lower sidewalk area of the Buarque de Macedo bridge: a) Digital image and b) Thermogram. Source: The Authors

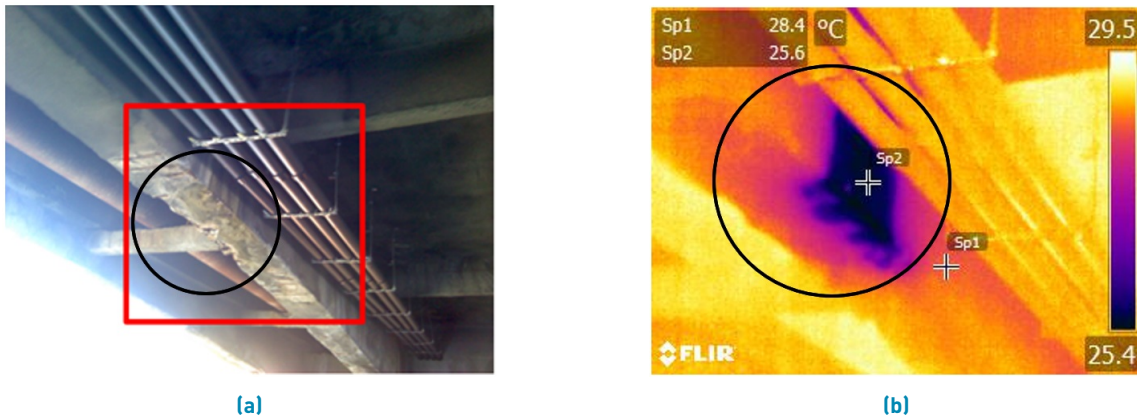
Figure 12a displays a deteriorated area with corroded and exposed steel from the Buarque de Macedo bridge. Figure

12b shows that this area is completely cold compared to other areas,  $-2.8\text{ }^{\circ}\text{C}$  (Sp2-Sp1), suggesting a large area delaminated by corrosion due to the wetting and drying process that this sector underwent. Moreover, a possible infiltration in the bridge is considered, among other factors, as the cause of this behavior.

**Figure 12** Buarque de Macedo bridge infrastructure: a) Digital image and b) Thermogram. Source: The Authors

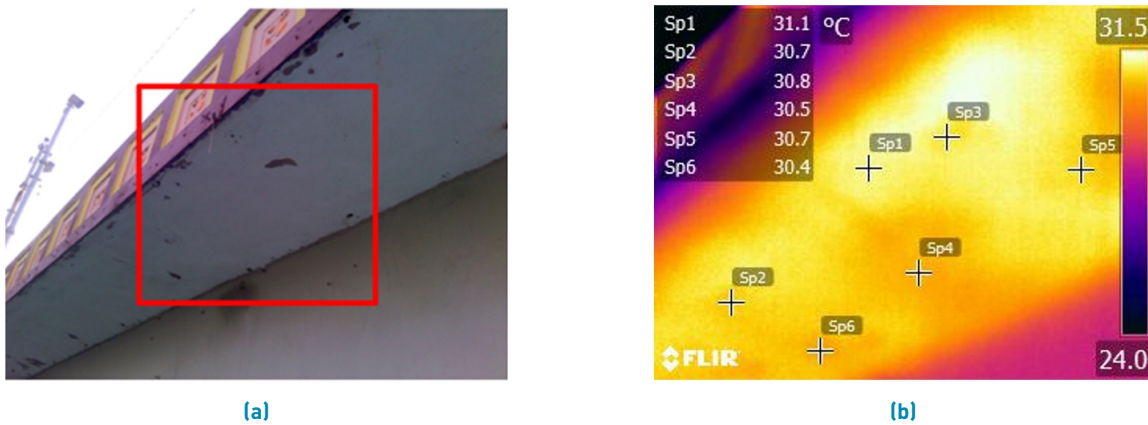
Figure 13a presents the lower section of the footpath of the Maurício de Nassau bridge. This section is in the south direction (S), which does not receive direct sunlight during the day. In Figure 13b, the detachments and defects are also shown as cooler areas. The temperature differences of the analyzed points are:  $-0.4\text{ }^{\circ}\text{C}$  (Sp2-Sp1),  $-0.3\text{ }^{\circ}\text{C}$  (Sp3-Sp1),  $-0.6\text{ }^{\circ}\text{C}$  (Sp4-Sp1),  $-0.3\text{ }^{\circ}\text{C}$  (Sp5-Sp1) and  $-0.7\text{ }^{\circ}\text{C}$  (Sp6-Sp1).

**Figure 13** Lower area of the Maurício de Nassau Bridge sidewalk: a) Digital image and b) Thermogram. Source: The Authors
