Title: **Failure analysis of fractured valves for Ar-CO₂ gas storage steel cylinders**

To appear in: *Revista Facultad de Ingeniería Universidad de Antioquia*

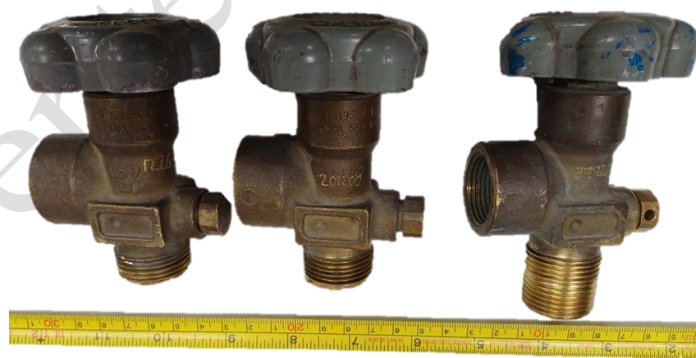
Figure 1 shows the three valves. One of the cylinders has a siphon tube, which is a sign of an operation that requires liquid CO₂. During the siphon tube disassembly, it experienced an abnormal longitudinal fracture, therefore, it was also analyzed in this work. **Figure 2** shows this component. The valve's fracture location diagram is presented in the results section and the cracks extended from the valve inner thread to the outer thread.

Figure 1. From left to right: Valve 1 and 2 (Failed), Valve 3 (without failure).

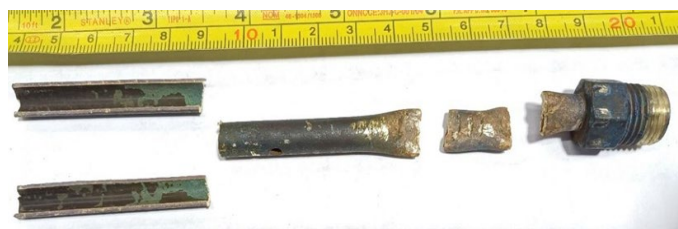
Figure 2. Siphon tube with fitting fractured during the disassembly.

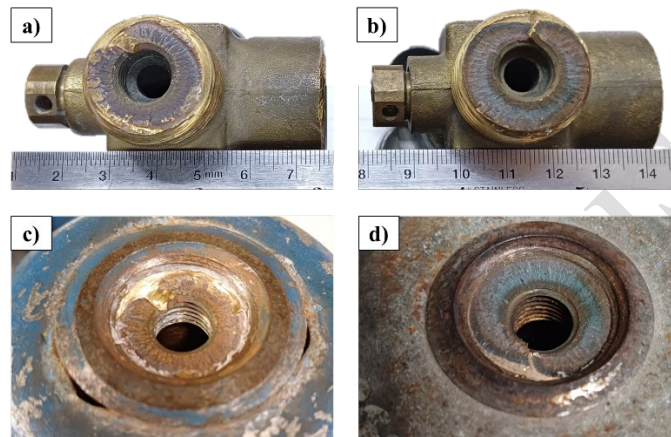
Figure 5a shows the fracture surface of Valve 1 and **Figure 5c** shows Valve 1's remainder inside its matching cylinder. **Figure 5b** shows the fracture surface of failed Valve 2 and **Figure 5d** shows Valve 2's remainder in its cylinder. Fracture surfaces with different tones are clearly observed in the cross-sections. Fractographic analysis was conducted on fracture surfaces to identify possible crack initiation points and failure mechanisms indicating the root cause.

Figure 5. Failed valve's fracture surfaces.

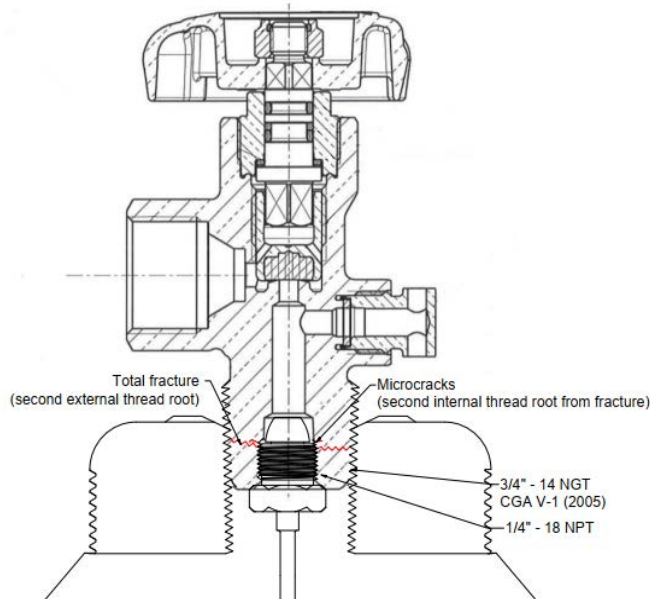
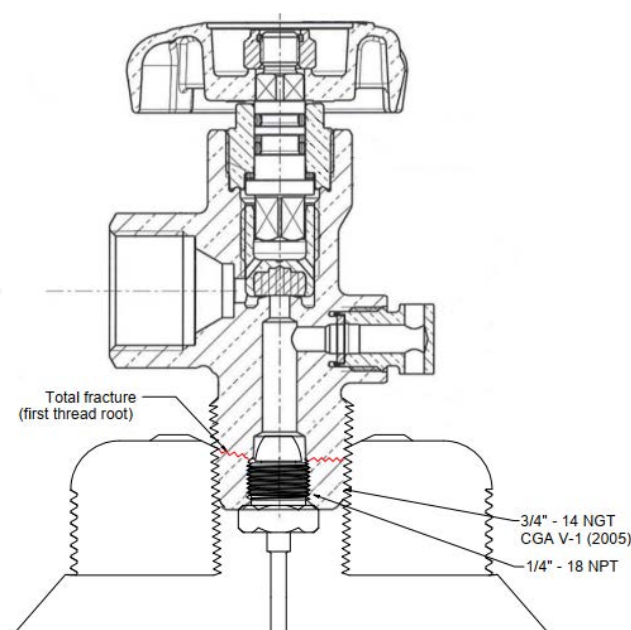
The failure location of the two valves is presented in **Figure 6**. The failure occurred in the threaded section near the outer surface of the cylinder cap, which (i) is subjected to bending stress during operation (this will be discussed in the stress analysis section), and (ii) is exposed to contaminating elements.

Figure 6. Fracture diagram of the analyzed valves. Valve 1 (Top). Valve 2 (Bottom).

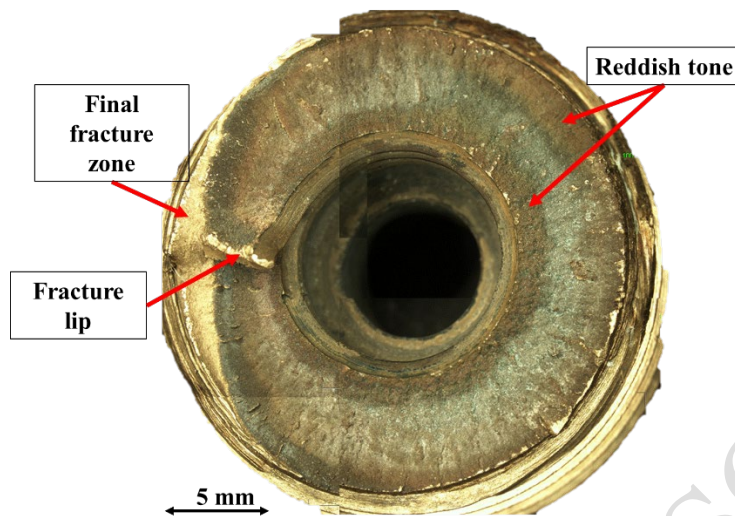
Figure 7 shows the appearance of the fracture surface of the failed Valve 2. The failure surface lacks markings indicating progressive failure (such as fatigue). However, different zones with varying corrosion conditions are present, as indicated by the color differences. The dark area with more advanced corrosion exhibits a reddish tone and is mainly localized at the root threads. Additionally, a yellow metallic luster is observed on the fracture surface, indicating the final rupture zone. This region shows a fractured lip, indicating the last material separation occurred with high plastic deformation. Furthermore, significant plastic deformation was evident on the threads of the two failed valves, indicating high loads during service.

Figure 7. Failed Valve 2 fractured surface.

On the other hand, there are some indications regarding possible overload. The first one is located on the fracture surface, where a metallic yellow-shine zone is observed, indicating the final fracture zone. This region exhibited a fracture lip, marking the location of the last material detachment accompanied by high plastic deformation (see **Figure 7**). Additionally, the thread fillets of both failed valves showed

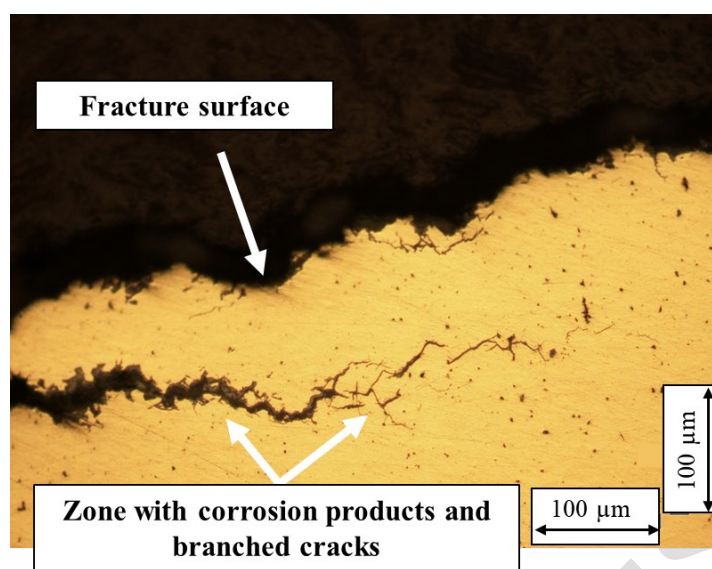
Figure 8 shows a micrograph of the external fracture surface of Valve 1 under an optical microscope. The fracture surface exhibits different zones with corrosion products and small cracks that propagate in a tortuous and branched manner into the material. The presence of these cracks and corrosion products on the fracture surface is uncommon in failures of metallic elements subjected to pure mechanical loads without significant environmental influence, serving as clear evidence that the fracture resulted from interaction with a medium that altered the base material of the valve [4].

Figure 8. Fracture zone detail of failed Valve 1.

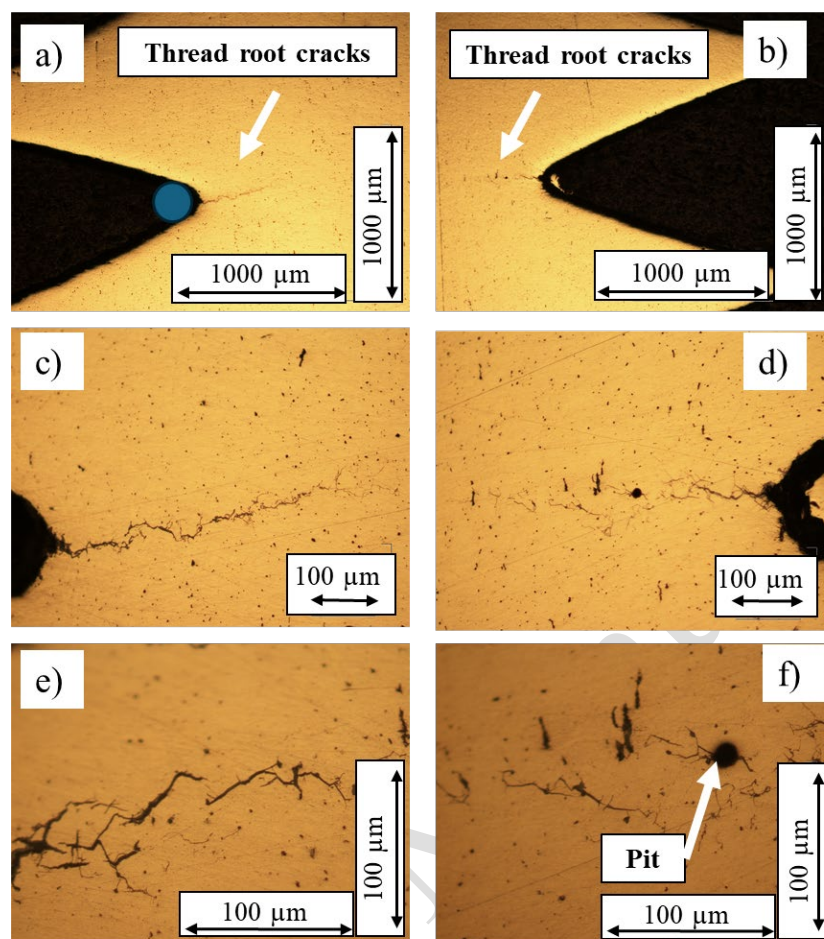
Figure 9 shows the longitudinal cross-section of the inner threads of failed Valve 1 (thread ¼”-18 NPT), observed under an optical microscope. Cracks are observed at the roots of the internal threads of the valve, propagating from inside (see **Figure 9a** and **9b**). The appearance of these cracks is very similar to those found on the fracture surface of the valve (see **Figure 9c** and **9d**). Additionally, the presence of pores or pits in regions near the cracks is observed (see **Figure 9e** and **9f**). The tortuous and branched cracks with corrosion products can be clear evidence of SCC as reported by other authors [13]. **Figure 10** shows a micrograph of the etched thread cross-section. Reddish zones are observed due to dezincification [5]. **Figure 11** exhibits deformed grains on thread fillets.

Figure 9. Cross-section of the inner threads of failed Valve 1. Optical microscope.

Valve 1 had evidence of SCC (**Figure 9**). SCC occurs when three conditions are present: the presence of a corrosive environment, the material's susceptibility to that environment, and mechanical stress applied to the component [4] [8]. The valves were subjected to stress generated by the internal gas pressure and/or stress produced during the assembly or disassembly of the valve during hydrostatic testing of the cylinders.

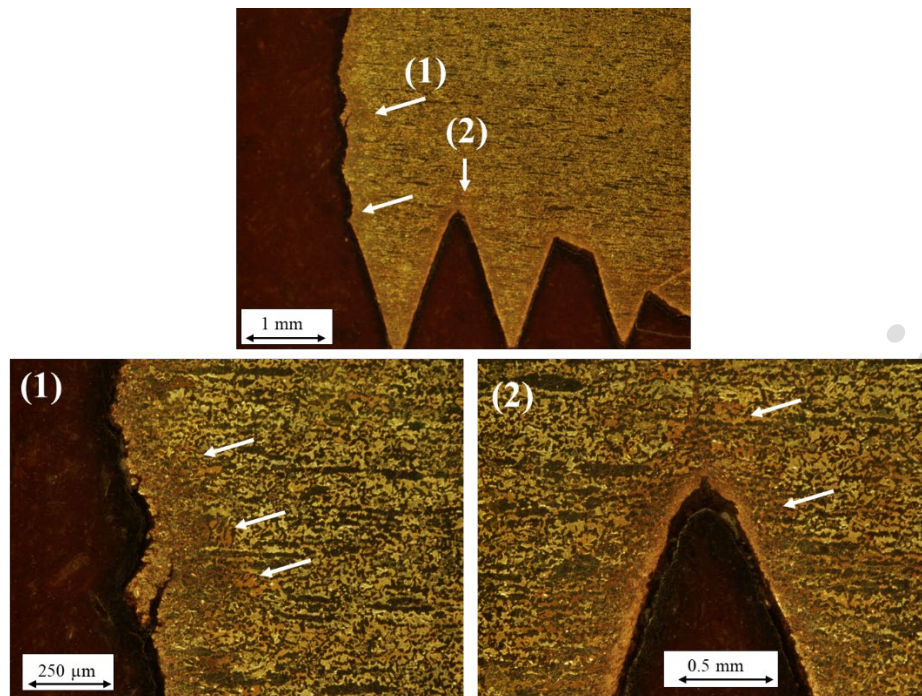
Figure 10. Reddish zones around inner thread cross-section.

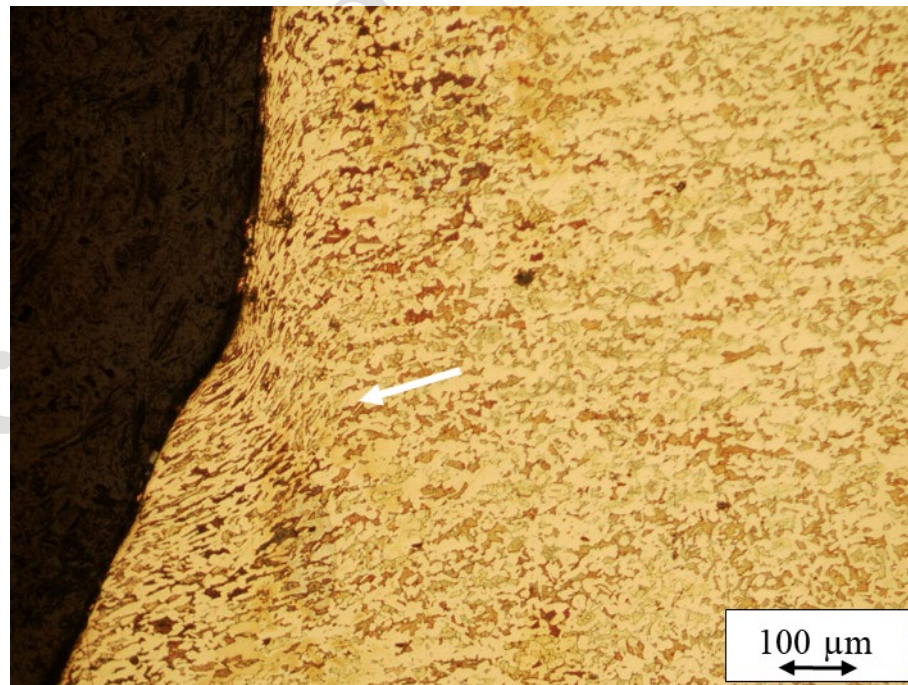
Figure 11. Deformed grains near failure zone

significant plastic deformation, suggesting the presence of high operational loads during service (see **Figure 11**).

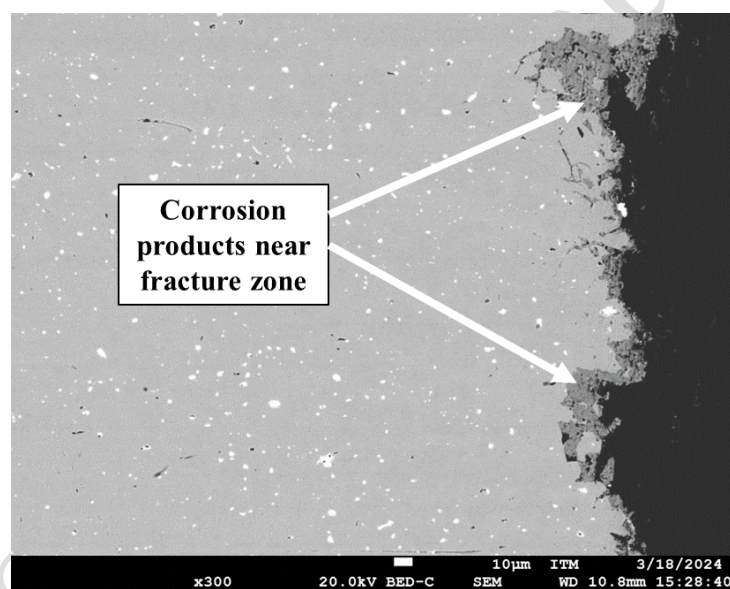
Additional inspection of the failed Valve 1 and the fractured siphon tube using chemical microanalysis and electron microscopy revealed an additional issue of high importance for the analysis. **Figure 12** shows images of the cross-section of the fracture surface observed under the scanning electron microscope. In **Figure 12**, the corrosion products, previously shown in **Figure 8**, are visible. Here, using backscattered electron microscopy, qualitative changes in the chemical composition of the material can be observed. A high amount of bright white particles, corresponding to lead particles, is observed, which is expected in these alloys because Pb is added to improve machinability. Additionally, dark gray zones with corrosion products are seen in the fracture section (right of **Figure 12**), indicating a different chemical composition from the base material. Furthermore, **Figure 12** shows the area near the fracture exhibiting significant porosity or pitting.

Figure 12. Cross-sectional surface of failure observed in scanning electron microscope.

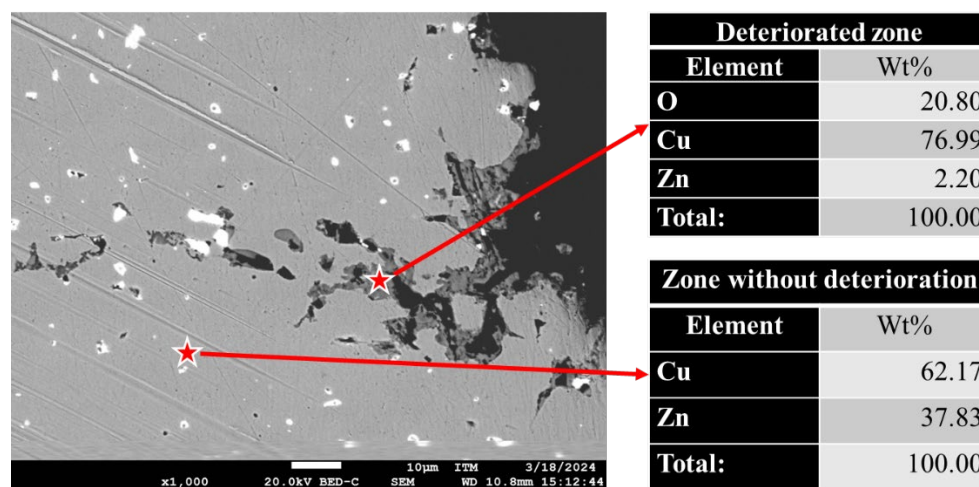
Figure 13 shows the results of the measurements of the chemical composition in a deteriorated zone (corroded area near the fracture) and in a nearby undeteriorated zone. The quantitative results are presented in the table attached to the same image. The results indicate that the deteriorated zone has significantly lower zinc levels compared to the expected values for the alloy. It is noted that in an undeteriorated zone, the zinc levels are between 35% wt. and 40% wt., while in the deteriorated zones, they are close to 2% wt. This result was supplemented by a qualitative linear analysis through the deteriorated zone, shown in **Figure 14**. The results showed that inside the areas with corrosion products, the amount of zinc significantly decreased to close to one-tenth (from 37% wt. to 2% wt.) of the average values in the undeteriorated zone.

Figure 13. Chemical composition analysis in the deteriorated zone and the undeteriorated zone.

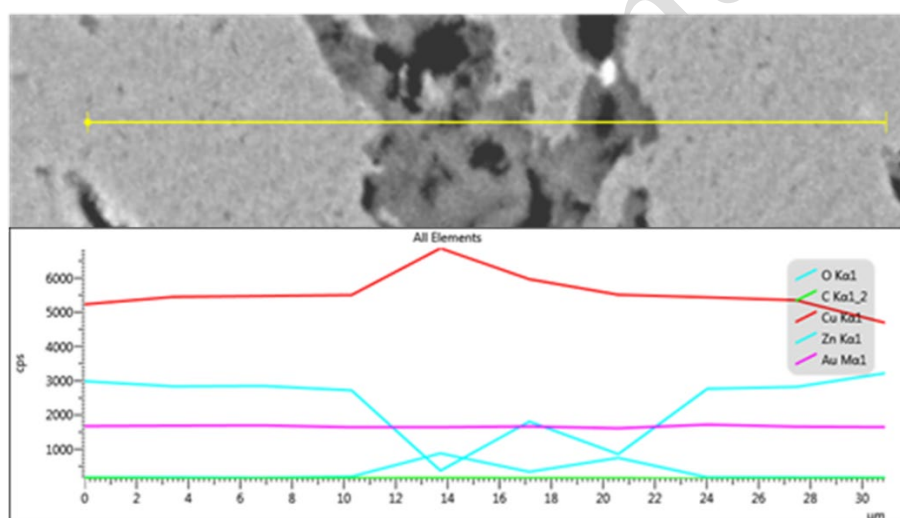
Figure 14. Linear analysis of element variation from an undeteriorated zone to a cracks and internal oxides zone.

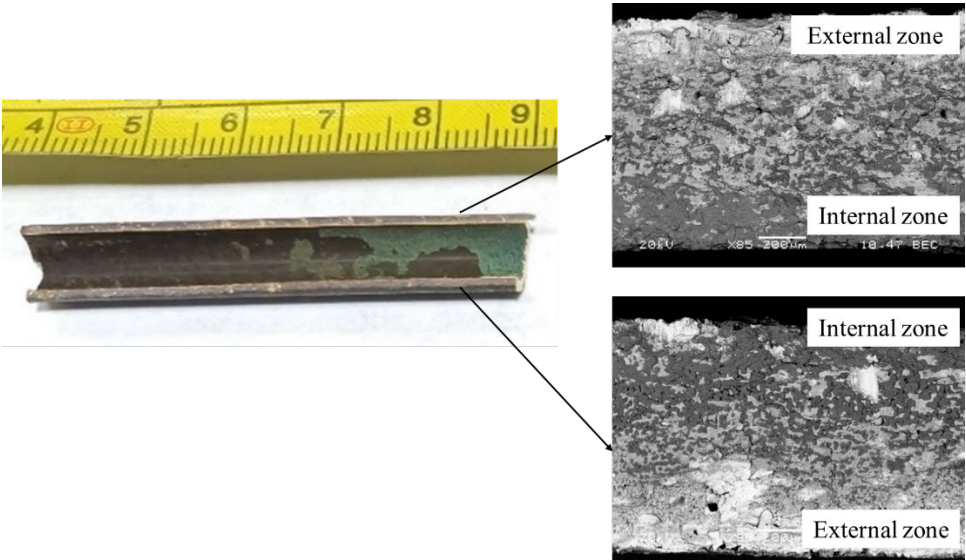
Since dezincification was found in Valve 1 (failed), an analysis was conducted on the anomalously fractured siphon tube. **Figure 15** shows the failed siphon tube and the analysis of the fracture surfaces. This element is of high importance for the analysis, as it is made from a material similar to the valve

Summarizing, the evidence indicates that the siphon tube also experienced dezincification. This phenomenon caused the anomalous brittle rupture during disassembly. The authors consider that copper corrosion and simultaneous dezincification could indeed occur. However, since the handling of the sample by the company involved in the failure analysis is unknown, it is impossible to determine the exact timing of this phenomenon. It is noteworthy that dezincification and copper corrosion products preferentially appear in the internal area of the siphon tube, which may be due to the condensation of water vapor caused by the gas flow within the siphon tube and fitting.

Figure 15. Qualitative chemical analysis of abnormal fractured siphon tube with dezincification evidence.

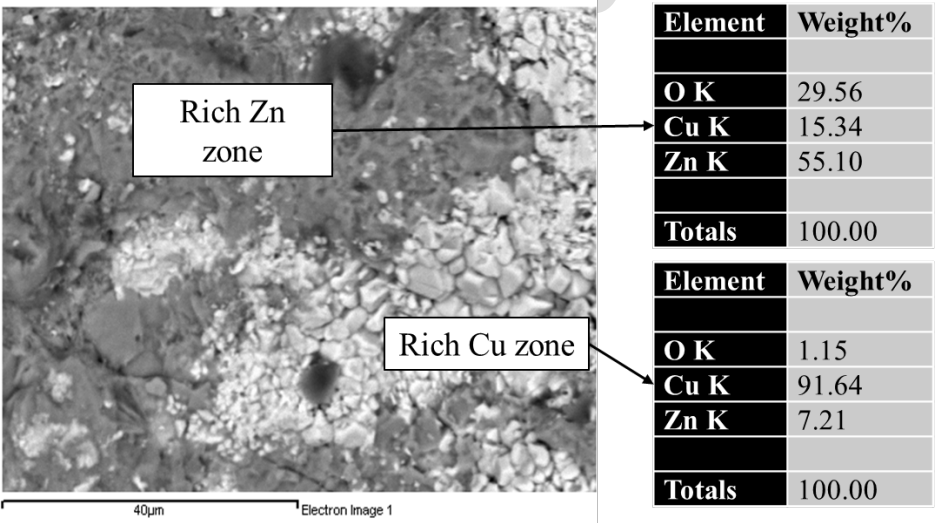
Figure 16. Siphon tube dezincification zones.

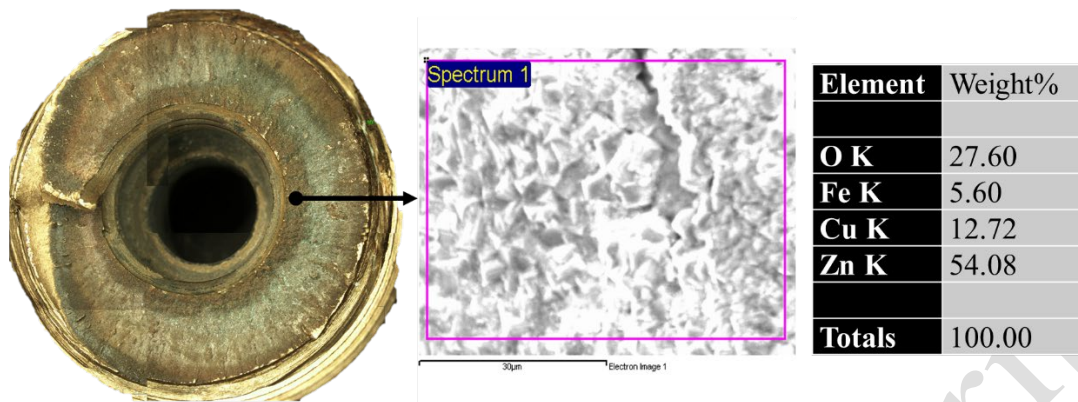
Finally, the authors verified that dezincification occurred in both valves. The unmodified fracture surface of failed Valve 2 was examined, and a chemical analysis was performed using the electron microscope. The red zone indicated in section 3.2 revealed the presence of areas with high zinc content (see **Figure 17**). These same areas have been documented in the literature as 'meringue' and were observed on the surfaces of the cylinder threads [3]. This result indicates that the dezincification phenomenon was also observed in both independent failure events.

Figure 17. Chemical analysis in fractured zone with high zinc content areas.
