Analysis and characterization of PV module defects by thermographic inspection

S. Gallardo, L. Hernández and O. Duque, "Analysis and characterization of PV module defects by thermographic inspection", *Revista Facultad de Ingeniería Universidad de Antioquia*, no. 93, pp. 92-104, Oct-Dec 2019. [Online]. Available: <https://www.doi.org/10.17533/udea.redin.20190517>

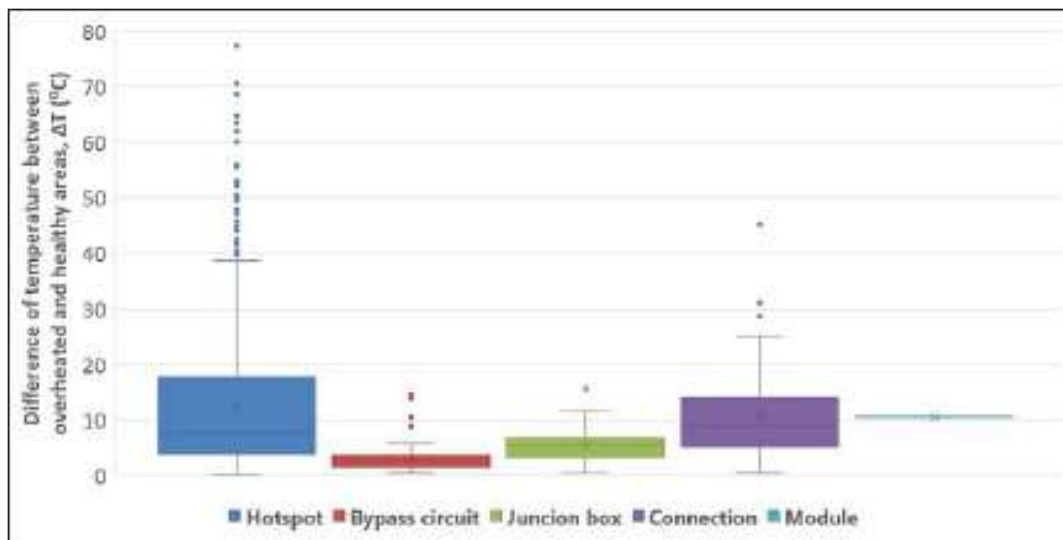
Figure 3 Box chart showing the difference of temperature between overheated and healthy areas, ΔT , grouped by defect type for each of the 1,140 defective modules detected

the severity of the anomalies for manual thermal inspection proposed in [17]. Differences higher than 30°C are considered as severe failures, from 10°C to 30°C are considered as medium severity failures, and lower than 10°C as minor failures. According to [23], temperature gradients lower than 10°C are normally considered as unproblematic and do not have to be listed separately. Temperature gradients from 10°C to 20°C are unproblematic in the current stage, although they have to be reported and observed in subsequent regular thermal inspections as they can increase during the operation of the PV power plant [23]. Differences of temperature above 20°C are expected to cause degradations of panel output and eventually, the material compound may even degrade, resulting in a safety issue. Table 3 summarizes the severity of all defects detected, grouped by defect type or affected component.

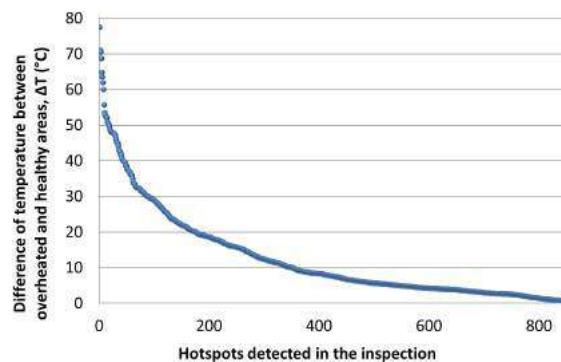
Reviewing all cells hotspot defects, it has been concluded that the pattern of this fault is an overheated cell, of approximate $15 \times 15 \text{ cm}^2$ depending on the module manufacturer, located in any cell along the module. The analysis performed does not reveal any preference of appearance of the overheated cell in any of the three strings circuits. The following figure, Figure 7, presents the ΔT of each of the 859 cell hotspots detected in the inspection in descending ΔT order, obtaining an average temperature of 12.4°C with a standard deviation on 12.8°C . Other relevant statistical values are the median, 7.4°C , and the first and third quartile, 3.8°C and 17.8°C , respectively. As it can be seen in Figure 7, the highest ΔT detected in the tests is 77.4°C , which supposes a cell hotspot

Figure 7 ΔT of each hotspot detected during the inspection in order from the highest to the lowest

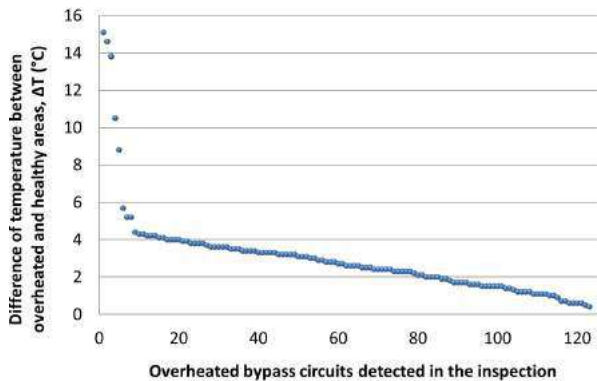
In case of a full electrical isolation of a cell part in case of cracks, the current produced by the broken cell, and subsequently by all the cells connected in series with it, decreases [22]. When a cell part is fully isolated, the current decrease is proportional to the disconnected area. In this case, it will appear a step in the I-V curve that originates two different MPPs, and some of the current could be derived through the substring bypass diode when the Global MPP appeared at the high current step of the curve, which could be revealed as an overheated point in the junction box if this is forced or conducting the excess of current for a long time, or as an overheated bypass circuit in case the bypass diode could not recirculate the excess of current, as it can be seen in Figure 8. Reviewing all bypass circuit defects it has been concluded that the pattern of this fault is two mainly homogeneous overheated columns of cells, with total approximate dimensions of 180 cm x 30 cm for 72 cells modules and 150 cm x 30 cm for 60 cells modules, depending on the module manufacturer. The overheated area can be located in any of the three strings of the module. The analysis performed does not reveal any preference of appearance of the overheated string in any of the three strings circuits. The following figure, Figure 9, presents the ΔT of each of the 123 overheated bypass

circuits detected in the inspection in descending ΔT order, obtaining an average temperature of 3.0°C with a standard deviation on 2.3°C. As it can be seen in the figure, most of these defects present a ΔT under 4°C. Only 8 modules (which supposes a 6.5%) present a ΔT over 4°C and only 4 modules (3.25%) have a ΔT over 10°C. The maximum ΔT detected has been 15.1°C. Other relevant statistical values are the median, 2.6°C, and the first and third quartile, 1.7°C and 3.6°C, respectively.

Figure 9 ΔT of each bypass circuit overheated detected during the inspection in order from the highest to the lowest

in the modules, as the power dissipated in the fault decreases with respect to the temperature reached in a longer series of cells. However, authors in [39] conclude that the reliability of the bypass diode function remain uncertain and it is recommended to use application of specific PV modules with custom design of bypass diodes for specific applications in which high temperatures can suppose a risk hazard, as hydrocarbon industries.

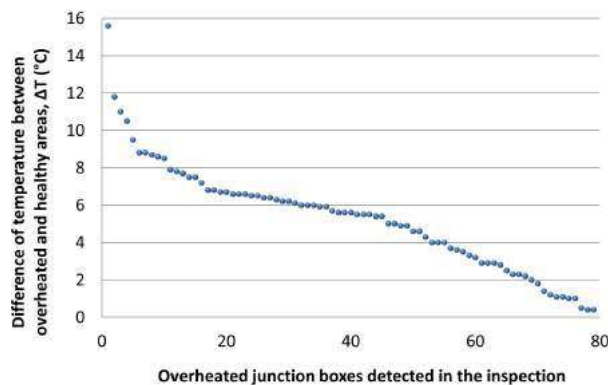
In relation with the pattern this kind of defects present, it has been shown that they are revealed as an overheated point in the middle part of the shorter side in which the box is located. This overheated point habitually appears in the middle of two different cells. In the PV plant in which the research has been performed, the modules of the upper row have the junction box underneath while the modules of the second row have the box in the upper part, as it can be seen in Figure 11 and Figure 12. The location of junction boxes along rows must be considered if a software must classify automatically the defects. The following figure, Figure 13, presents the ΔT of each of the 79 overheated junction boxes detected in the inspection in descencing ΔT order, obtaining an average temperature of 5.3°C with a standard deviation on 2.8°C. The maximum ΔT detected has been 15.6°C. Other relevant statistical values are the median, 5.6°C, and the first and third quartile, 3.3°C and

Figure 13 ΔT of each junction box detected during the inspection in order from the highest to the lowest

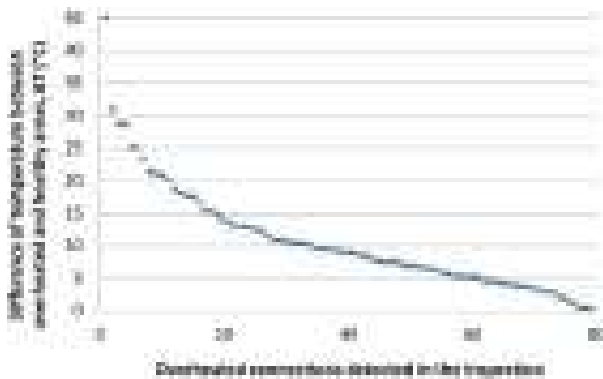
Reviewing all connection defects, it has been concluded that the pattern of this fault is an overheated point, generally smaller than a cell, located next to the frame in the same side in which the junction box is placed. The following figure, Figure 15, presents the ΔT of each of the 78 overheated connections detected in the inspection in descending ΔT order, obtaining an average temperature of 10.9°C with a standard deviation on 8.1°C. The maximum ΔT detected in this case has been 45.1°C. Other relevant statistical values are the median, 9.0°C, and the first and third quartile, 5.2°C and 13.8°C, respectively.

Figure 15 ΔT of each overheated connections detected during the inspection in order from the highest to the lowest
