A comparative surface analysis of explanted hip joint prostheses made of different biomedical alloys

Angela Bermúdez-Castañeda

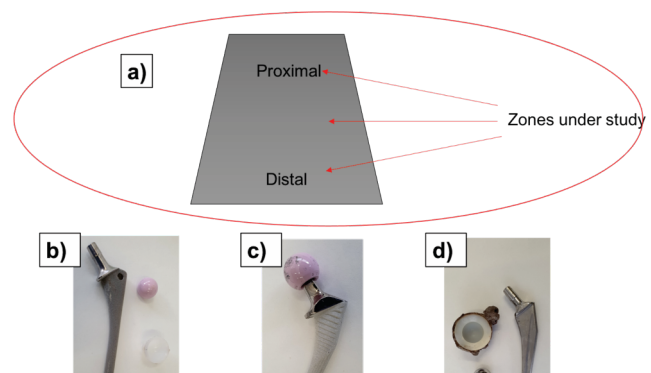
1 year for the CoCr trunnion, around 10 years for the 316SS, while the Ti6Al4V trunnion was implanted for 8 years, approximately. All of them were removed because of infection and pain. Once explanted, the hardness of the trunnions was measured at the surface and in the bulk. Also, the chemical composition was determined by means of energy dispersive X-ray (EDX). In order to analyze wear on the trunnion surfaces, a scanning electron microscopy (SEM) was carried out using a Zeiss GEMINI 300 scanning microscope at a high vacuum environment, and optical profilometry was performed. All SEM images were made using an acceleration voltage of 3 kV and a working distance of 6 mm. 3D profiles were taken using a Laser Scanning Confocal Microscope, Keyence VK-X200 Series 3D. Data analysis was developed using the MultiFileAnalyzer 1.3.0.115 software. Figure 1 shows the prostheses under study and the analyzed zones: proximal, distal, and intermediate zones.

Figure 1 Schematic diagram a) the zone under study, and analyzed prostheses showing trunnion/head pairs b) CoCr / alumina, c) Ti6Al4V/Alumina and d) Stainless Steel/CoCr

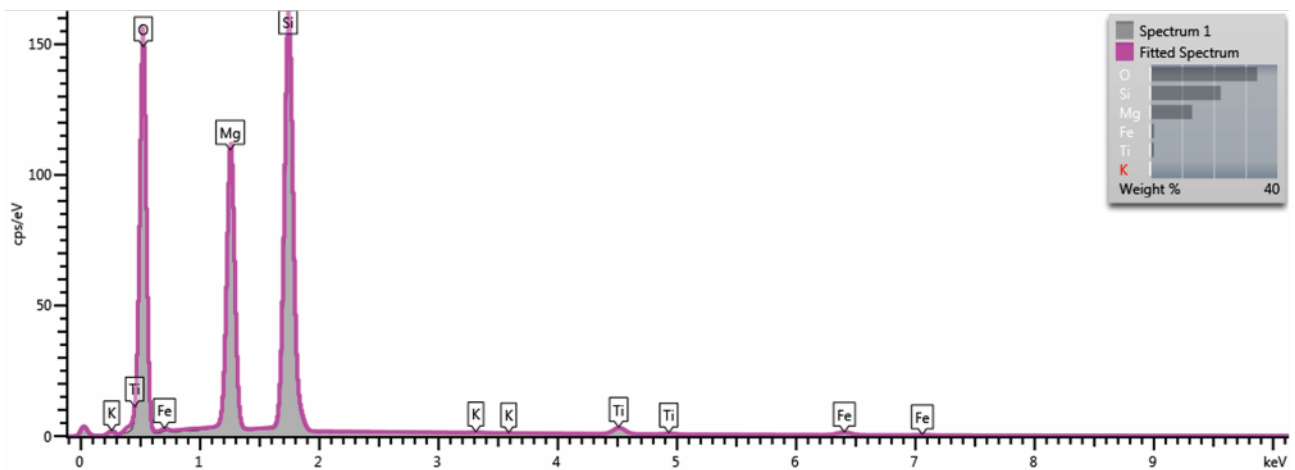
Images from the middle part of the trunnion show ploughing, although to a less severe degree than in the distal area. Moreover, some particles of organic material (biofilms), which composition is shown in Table 3 and Figure 4, can be found at this distance, as shown in Figure 3 **d)**. The entry of this material shows that even if the obstruction is produced at the entrance, material and particles can pass through the length of the trunnion.

Figure 4 EDX spectrum of biofilm on Ti6Al4V surface trunnion

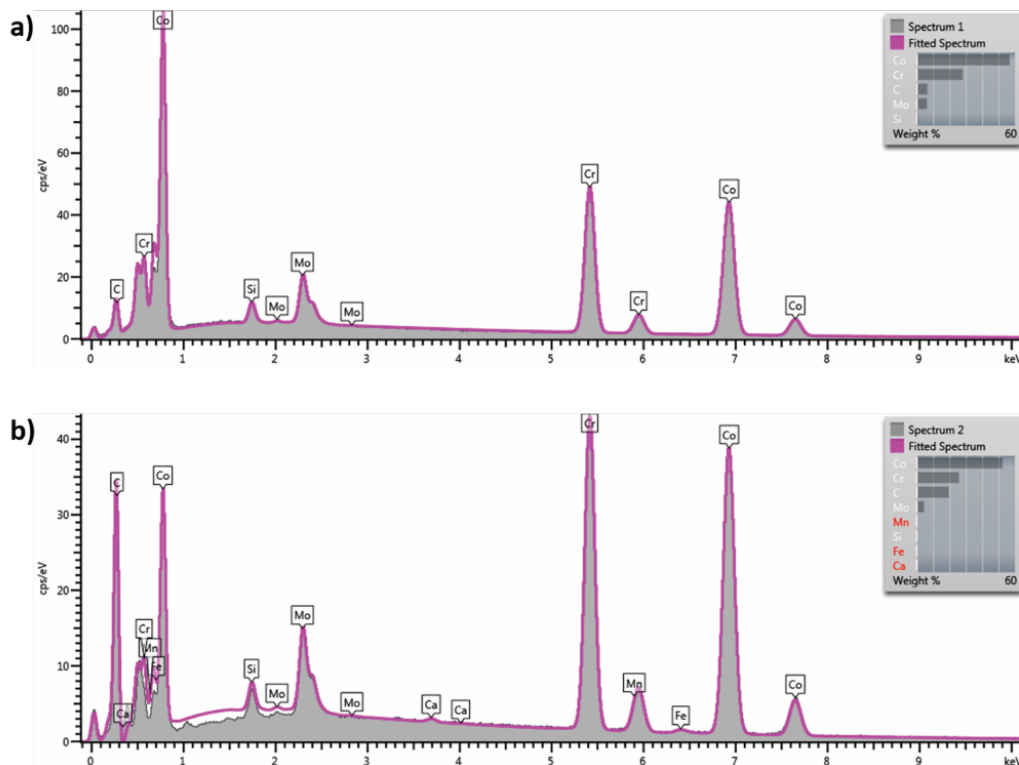
The trunnion made from CoCr alloy was characterized through EDX analysis. The corresponding spectra are shown in Figure 7, and the composition from different parts is indicated in Table 4. According to the literature, the identified composition corresponds to a typical CoCr biomedical alloy [22]. Despite this, elements such as Co, Cr, and C show higher concentrations, which may correspond to material transfer and body fluids. Taking into account that the femoral head was made from CoCr, as the trunnion, the material transfer cannot be successfully identified.

Figure 7 EDX spectra from a) distal part, and b) proximal part of CoCr explanted prosthesis

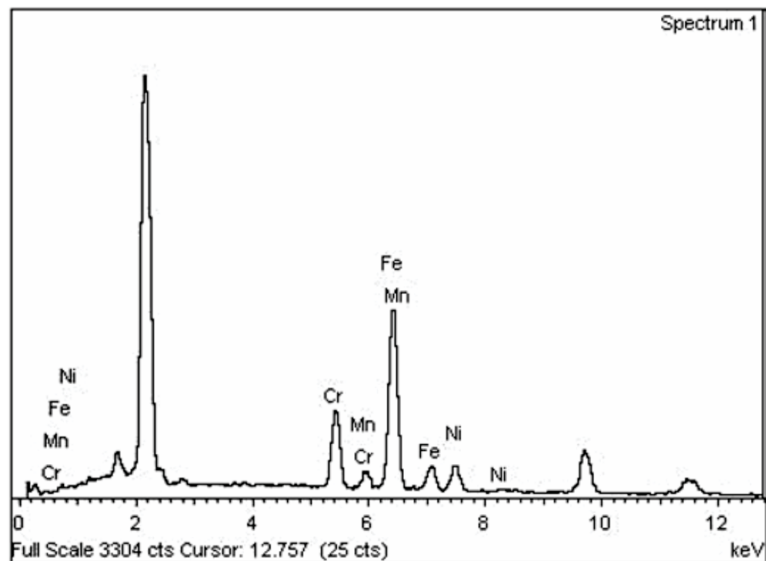
The explanted stainless-steel trunnion, as well as the Ti-6Al-4V and CoCr prostheses, are subjected to surface texturization to promote adhesion, as can be seen in Figure 10 **a)** and **c)**. The chemical composition by EDX is shown in Table 5, the spectrum shown in Figure 11. SEM images of each part of the trunnion are shown in Figure 10. The distal part exhibits a higher intensity of damage than the proximal part.

Detached particles can be observed in Figure 14. These particles have the same chemical composition as the SS prosthesis. Moreover, no oxygen is observed, which indicates the presence of metallic material. In addition, EDX analysis in Figure 15 shows a material layer formed on the material surface similar to those reported in previous studies [16, 25], [26]. These films, known as a tribofilm, are formed by the oxidized and metallic material worn from both interfaces in contact. The layer was found on the explanted trunnion of 316L stainless steel, which was paired against a Co-Cr alloy head. The alloy contains an average of 18.55% of Cr, according to EDX (see Table 5 and Figure 11). However, the chemical analysis of the surface

Figure 11 EDX spectrum of SS surface trunnion
