Title: **Failure analysis of fractured valves for Ar-CO₂ gas storage steel cylinders**

To appear in: *Revista Facultad de Ingeniería Universidad de Antioquia*

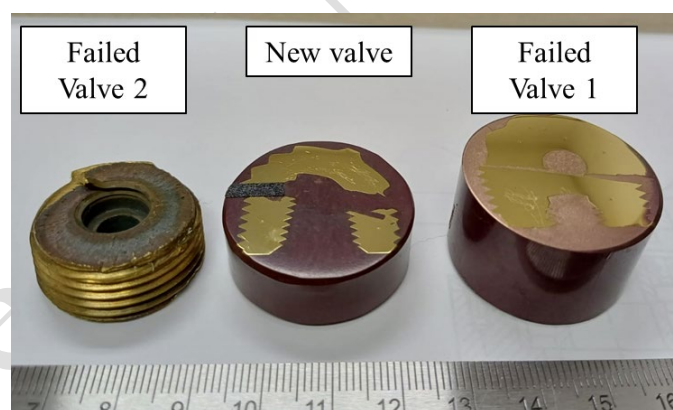
Figure 3. Samples of the analyzed valves.

Valve 2's body was transversally cut, and the lower portion of the threaded region —containing the fracture surface —was separated and preserved intact for inspection under a stereomicroscope, as shown in **Figure 3**. The fracture surface of Valve 1 (failed) and Valve 3 were sectioned and mounted in resin to observe the fracture cross-section using optical microscope (MOP) and scanning electron microscope (SEM). **Figure 3** presents the three analyzed samples.

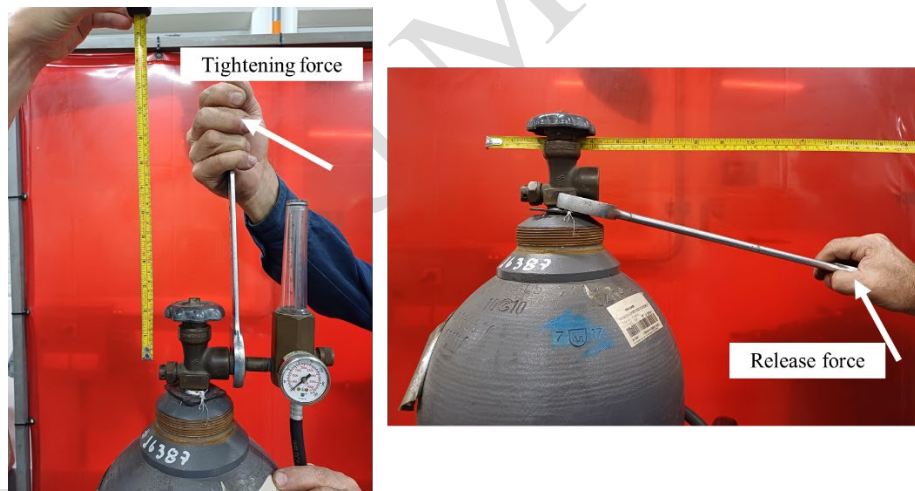
Figure 4. Cases for the analysis a) Normal operation. b) Valve disassembly.

Two cases were selected to perform the analysis and to determine the stresses in the valve, as shown in **Figure 4**. The first case involves the normal operation of the cylinder in the welding shop, with an internal pressure of around 3000 psi; an operator disassembles the flow meter, or similar, using a wrench on the external part of the valve. The second case involves the valve disassembly from the cylinder to carry the hydrostatic testing.

In the first case, the valve is subjected to torsional and bending moments from the applied force shown in **Figure 4a**, when the flowmeter is connected. Additionally, the valve thread endures tensile stress due to internal gas pressure. This internal pressure decomposes into two main forces generating tensile stress in the valve's threaded region where failure occurred. The force on the valve stem's internal surface (F1 in **Figure 18**) reaches 67 kgf, derived from an internal pressure of 3000 psi over a $\frac{1}{4}$ " diameter circle. The force F2 achieves 1004 kgf from a 3000 psi pressure over an area with a 1" outer diameter and a $\frac{1}{4}$ " inner diameter. Thus, the resultant tensile force reaches 1071 kgf, producing a tensile stress of 22.5 MPa, excluding stress concentrations from the threads.

During the valve removal for hydrostatic testing of the cylinder (**Figure 4b**), a force of 30 kgf is applied at 30 cm, generating a torsional moment (T) of 88 Nm. The resulting shear stress, calculated using **Equation 3**, is 27.5 MPa. After applying a concentration factor ($k_2 = 1.7$) through **Equation 4**, the corrected shear stress is 46.8 MPa. Additionally, this force generates a bending moment (M) of 11.8 Nm, resulting in a bending stress of 7.3 MPa, calculated using **Equation 1**. After correcting the value with **Equation 2**, the bending stress reaches 18.5 MPa. Consequently, the safety factor for this case is 4.09.
