Experimental analysis of the vibration on the draft tube of a Francis hydraulic turbine during operation at different power levels

Fernando Casanova García, Carlos Alberto Mantilla Viveros*

Universidad del Valle, Escuela de Ingeniería Mecánica, Calle 13 N.º 100-00, Edificio 351, Oficina 2007, Cali, Valle, Colombia.

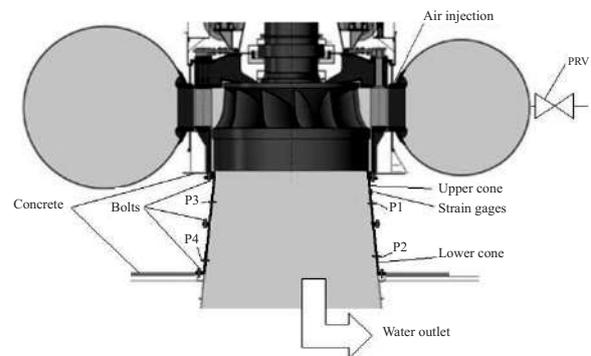
The draft tube on each unit is composed of two parts: the part near the turbine is formed by two uncovered cones made of a low-carbon steel wall 18 mm thick and the other part, which is far from the turbine, is embedded in concrete. The two uncovered cones are joined to each other by bolts and in the same manner are joined to an upper and a lower flange embedded in concrete. Between the lower cone and the lower flange, a segmented ring with wedge form in the cross section is assembled to compress the cone against the flanges and to guarantee fixation and sealing. A sketch of the assembly of the two cones is shown in figure 1.

Figure 1 Sketch of the non-embedded part of the draft tube

Internal pressure was measured on four points: two on the upper cone and two on the lower aligned with the water outlet. In figure 1, the pressure sensors are labelled as P1, P2, P3, and P4. P1 corresponds to the pressure sensor located at the upper cone on the side over the water outlet. Pressure was measured by using PX305-300 GI Omega pressure transducers with a range of 0-300 psi (0-2,066 kPa). Pressure signals were registered by using a NetDAQ 2645A Fluke data acquisition system.

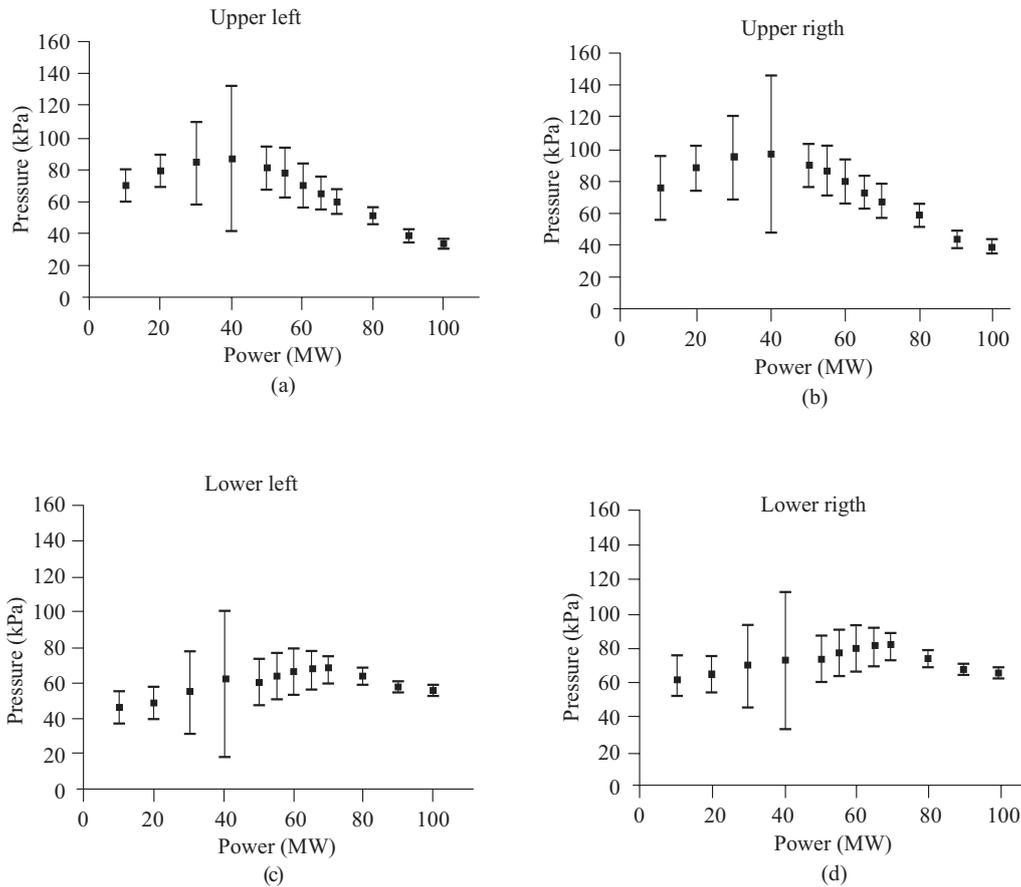
Figure 2 shows the average pressure and its corresponding standard variation as a function of power for the tests conducted while units one and three were stopped. The maximum pressure fluctuation in the four positions was obtained at 40 MW. Note in the figure that for low powers, the pressure is higher on the upper positions and for power above 60 MW the pressure on the upper positions is lower. This means that at low power the pressure is mainly the dynamic component, which is higher in this condition due to the vortex. At power greater than 60 MW, the dynamic component decreases and the static component is important. Given that the static component is due to the water level; then, pressure is higher on the lower positions.

Figure 2 Pressure as a function of power. Units one and three stopped

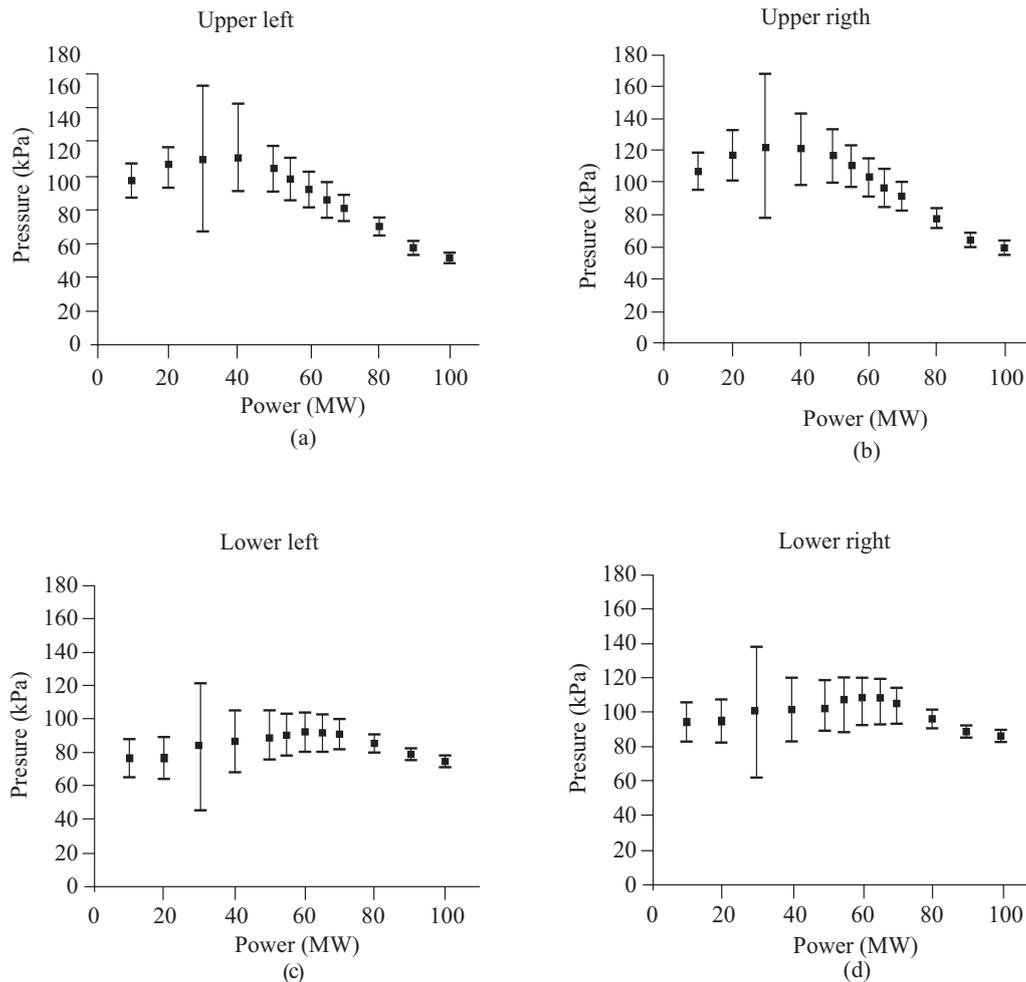
A slightly different behavior for pressure was found when units one and three were working at 95 MW, as seen in figure 3. Under this condition, in general, pressure was higher than when those units were stopped. Another difference is that the maximum pressure fluctuation was registered at 30 MW for the four points, rather than at 40 MW as in phase 1.

Figure 3 Pressure as a function of power on the four points measured when units one and three were working at 95 MW

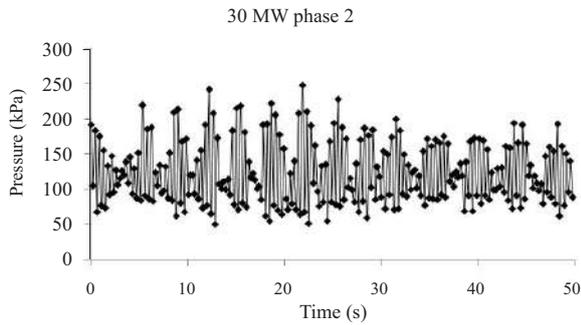
In all conditions tested, pressure was greater on the right side. From the conditions tested, the most critical was when the machine was working at 30 MW while units one and three were working at 95 MW. These results are shown in figure 4. By applying the Fast Fourier Transform to these data, frequencies were obtained of 0.29 and 2.2 Hz; both lower than the runner frequency (3 Hz). The amplitude was higher at 2.2 Hz than at 0.29 Hz. According to the literature [1, 7, 8], the vortex rope in the draft tube is the main contributor of

these low-frequency pulsations; although 0.29 Hz corresponds to approximately 0.1 times the runner frequency, out of the range between 0.25 and 0.35 times the runner frequency mentioned by Escaler and colleagues [7].

Figure 4 Pressure fluctuation in the upper right point with unit two working at 30 MW and units one and three working at 95 MW

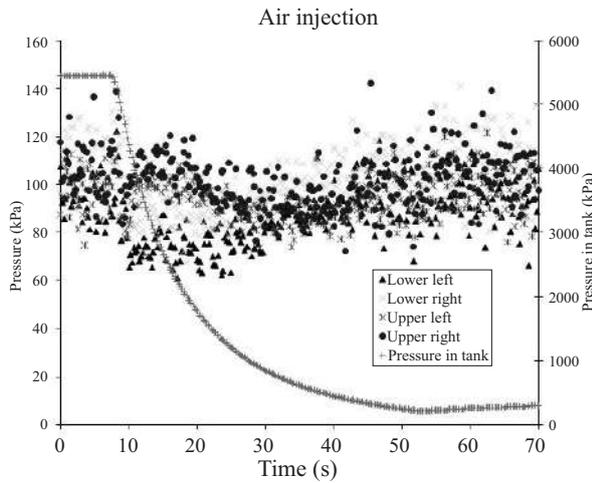
The opening of the PRV did not reveal any important effect on pressure. However, it was found that air injection considerably reduced the average and the fluctuation of pressure. figure 5 shows the pressure inside the cone and the pressure in the air storage tank. The beginning of the air injection is indicated by the decrease in the pressure of the air storage tank. In this figure, it can be seen that the average and the alternating pressure decrease while the air was injected. The vertical and horizontal lines in the figure indicate that the effect of air injection is important until when the pressure in the tank was 500 kPa. Up to that pressure, the average and the variation

of the pressure was considerably decreased. For example, taking upper right pressure for the first 10 seconds, the average and the standard deviation were 106.1 and 12.25 kPa, respectively; whereas, for the time between the 30 and 40 seconds the average and standard deviation were 93 and 7.15 kPa, respectively. That means a reduction of 12% in the average pressure and 41% in the standard deviation of the pressure. Due to the lack of an air flow meter in the air injection system, air flow was calculated by using Van Der Waal's real gas equation [9] to calculate the air quantity inside the tank at 31 and 38 seconds (figure 5), knowing the tank volume (2.95 m³), and the temperature at those pressures (26 °C). Air flow was calculated as the difference between

the air quantity at 31 seconds and at 38 seconds divided by 7 seconds. The air flow calculated was 0.207 m³/s. The water discharge in the turbine is 60.8 m³/s; therefore, there is a ratio between air discharge and water discharge of 0.34%. This air discharge effectively reduced the pressure pulsation even though it was lower than the ratio of 0.5% suggested in Ref. [1] as the ratio where the lowest amplitude is obtained. In fact, in figure 5, it can be noted that the lowest amplitude is between the 30th and 40th seconds, where the air flow was near that calculated above; but at times lower than 30 seconds, where the pressure is higher and, therefore, it is supposed that the air flow is higher, the pressure fluctuation is not as reduced as during the 30th and 40th seconds.

Figure 5 Pressure inside the cone and pressure in the air storage tank as a function of time during air injection

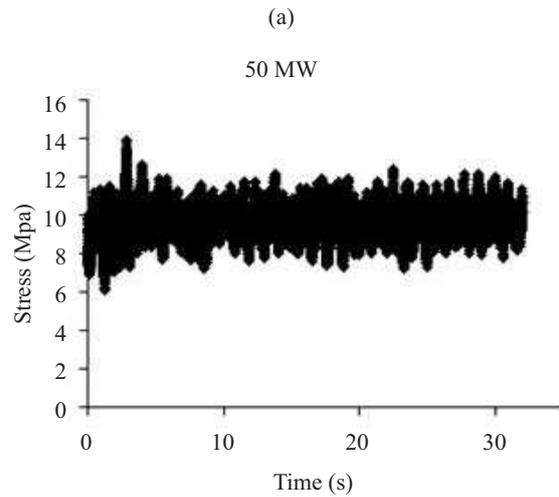
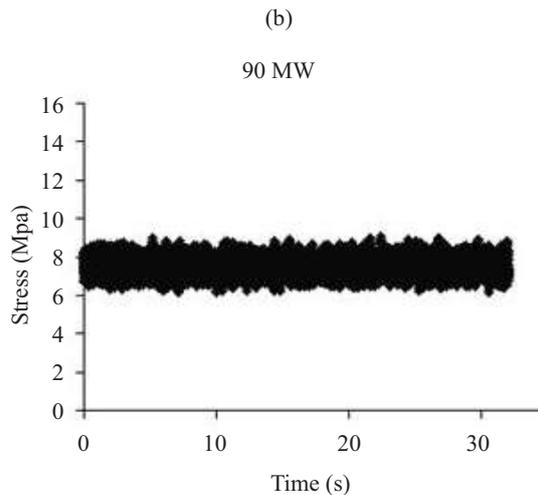
The influence of power on stress was clear. Figure 6 shows the von Mises stress at powers of 50 and 90 MW, while units one and three were stopped (phase one). Clearly, at 50 MW (partial load), the average and the fluctuation of the stress are higher than those registered at 90 MW. At 50 MW the condition of the structure is critical because it can cause break of the draft tube connecting bolts as is shown elsewhere [10].

Figure 6 Von Mises stress (a) 50 MW (b) 90 MW

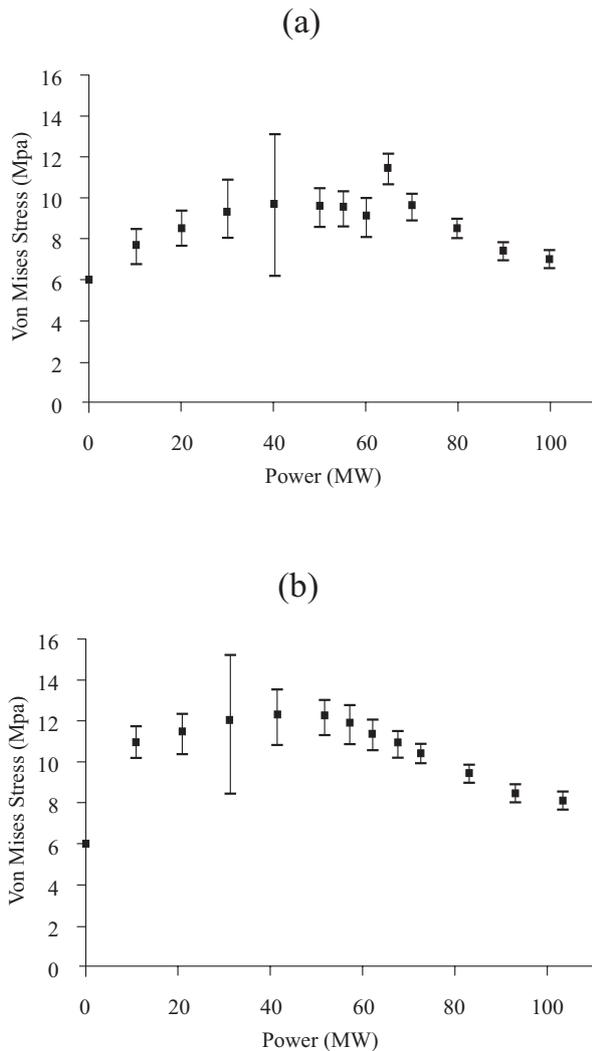
Figure 7 shows the average von Mises stress as a function of power in the two conditions: with units one and three turned off (figure 7 a) and with those units working at 95 MW (figure 7 b). The standard deviation is shown for each average value. It is observed that, in general, the stress is higher when units one and three are working. The maximum fluctuation of the stress – when units one and three were stopped – was obtained at a power of 40 MW and – when those units were working – the maximum fluctuation was at 30 MW. A clear increase of the average and the fluctuation was observed at partial load, along with an important decrease of the average and almost no fluctuation of the stress for powers

above 80 MW. The datum at 0 MW corresponds to the stress measured when the machine was stopped and after the draft tube was filled with water; hence, corresponding to the stress due to hydrostatic pressure.

Figure 7 Von Mises stress on the cone wall as a function of power (a) units one and three turned off (b) units one and three working at 95 MW

The average stress – with units one and three working – was higher than the stress with those units stopped. Similar behavior was found in the results of pressure inside the cone. Even though the

average stress increases with units one and three working, the stress fluctuation holds practically the same. Thus, it can be said that the increase of average stress and pressure are due to the increase of hydrostatic pressure given the higher tail water when the other two units are working.

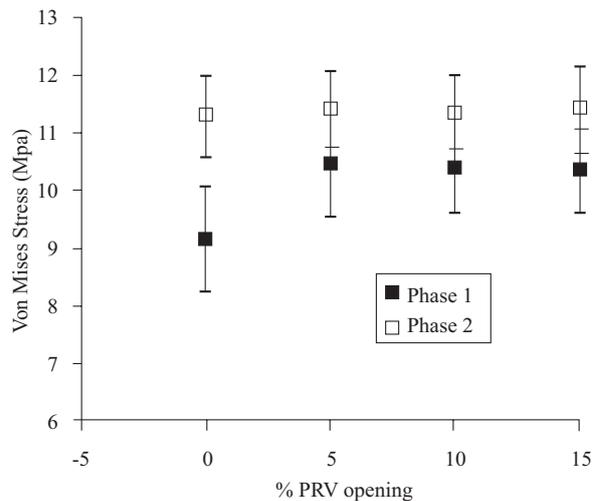
Figure 8 shows the von Mises stress in the cone wall as a function of the PRV opening at 60 MW power. It can be seen that the opening of this valve did not produce any beneficial effect on the stress. Even when units one and three were working, the opening of the PRV produced increase in the average stress. The increase in the average stress when the other two units were operating can also be observed in figure 8.

Figure 8 Von Mises stress as a function of the PRV opening under both conditions tested

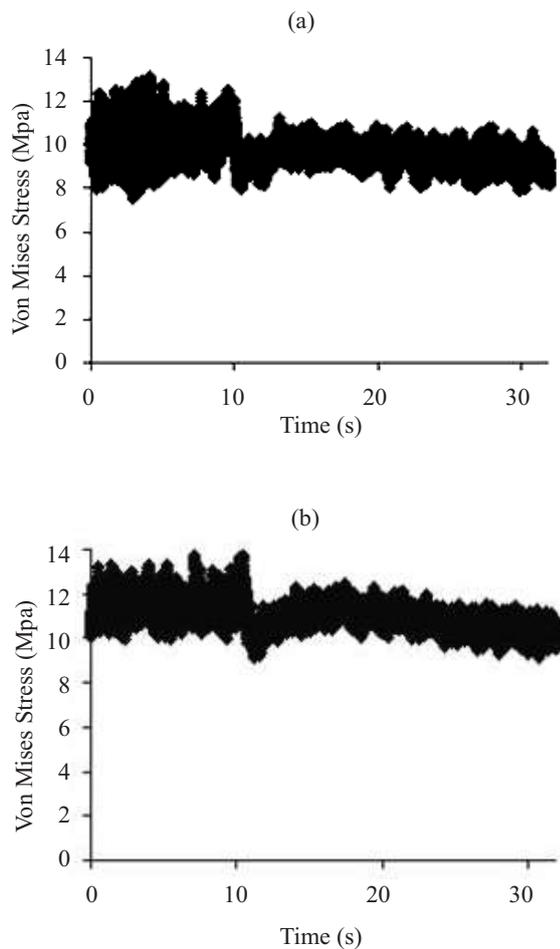
Similar to the pressure inside the cone, the stress on the wall was reduced with air injection. Figure 9 a, shows the von Mises stress on the cone wall during air injection when unit two was operating alone. Figure 9 b shows the stress when the other two units were working at 95 MW. Both measurements were taken while unit two was operating at 60 MW. The stress amplitude decreased from values as high as 2.65 Mpa, without air injection, to values as low as 0.95 Mpa, with air injection.

Figure 9 Von Mises stress on the cone wall during air injection: (a) with units one and three stopped; (b) with units one and three operating at 95 MW

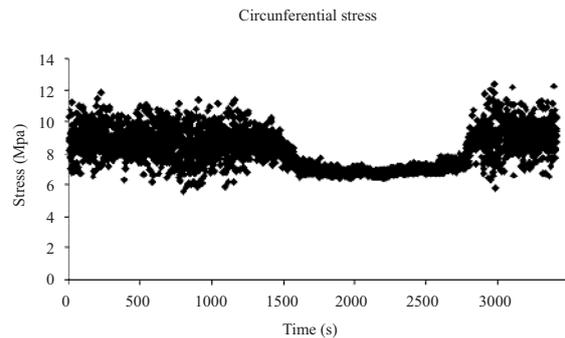
3 Hz runner frequency) and it is probably due to the von Karman vortex on the blades, which affects the tube wall. In this latter experiment, a clear decrease in the stress was found when the machine was at full load, as seen in figure 10.

Figure 10 Circumferential stress on the tube wall varying the power

From the conditions tested, the most critical for the cone wall was when unit two was operating at 30 MW and units one and three were operating at 95 MW. Under those conditions, the average von Mises stress was 11.9 MPa and the amplitude stress was 8.2 MPa. Therein, the frequency of the stress was 2.21 Hz; similar to that found in the pressure fluctuation (2.2 Hz). The low frequency, found in the pressure, was not detected in the stress measurements. A 39 Hz frequency was found when the machine was working at high powers (90-100 MW) and when the power was increased from 0 to 100 MW and decreased again to 0 MW. The 39 Hz frequency matches exactly with the blade passing frequency (13 blades and
