# Analysis of the quality of the welding process in the exchange of component of BGA technology

## Análisis de la calidad del proceso de soldadura en el cambio de componente de tecnología BGA

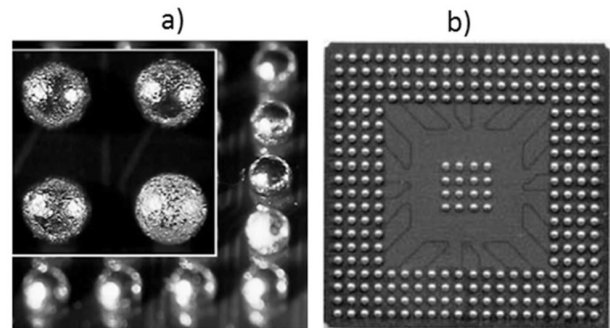
BGA is used in several types of components, among them, chipsets and memory chips. It is a component type where the contact terminals are spheres. Figure 1 shows a BGA component and its balls.

**Figure 1 View of the BGA Component: a) Zoom of the Spheres of the component; b) BGA Component [9]**

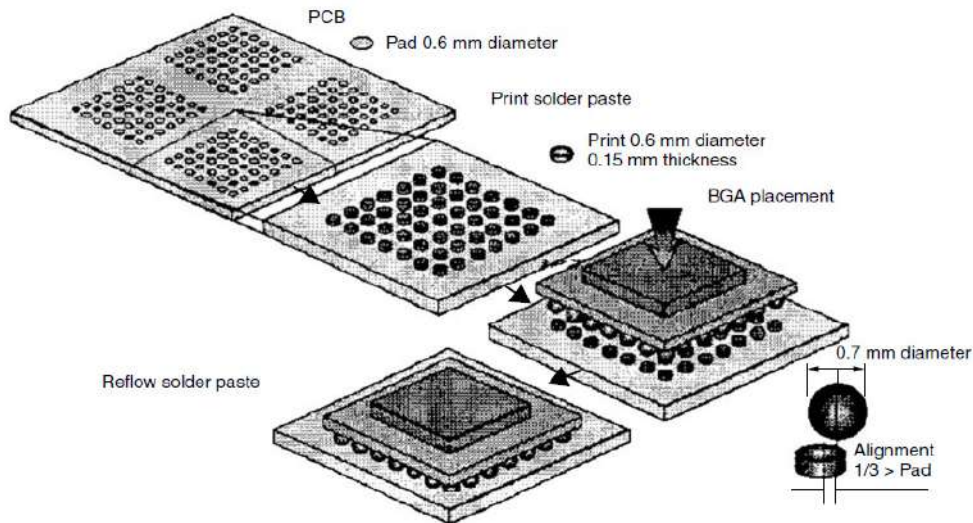
The Mother Board that receives this component passes by the SMT typical process: Printing of Welding Paste, procedure of welding paste application, assembly of the component (Place Component) and welding in a re-fusion furnace. After welding of the BGA on the PCI, the spheres (Balls) are not visible. Figure 2 illustrates the flow of the SMT process for the BGA component [9], in this process (1) it shows the PCB, (2) the printing of the welding paste on the PCB, (3) the assembly of the BGA component and (4) the welding of the component.

**Figure 2 Flow of the process of assembly of a BGA [9]**

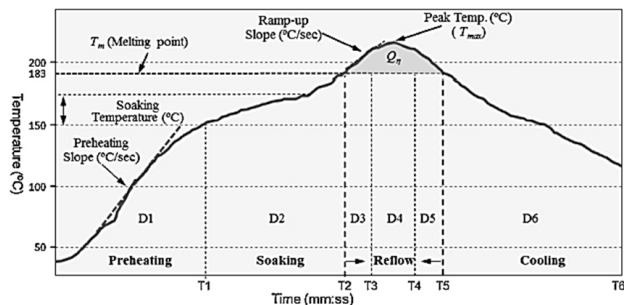
The Reflow Process is a part of the process of Surface Mount Technology (SMT), technology where the components are mounted directly on the surface of the printed circuit board [10]. Processes of SMT assembly lines usually involve welding paste, placement of components and the operations of Reflow Welding [11]. The Reflow welding process consists of heating up the whole mounted board to liquefy the solder paste to form welding unions between SMDs and PCB without altering the original characteristics of the electric components. It is used a reflow furnace to heat up the mounted boards to an appropriate temperature in a specified period of time to a tax of appropriate heating [12]. A characteristic model of recommended profile is described in the Figure 3 [12]:

**Figure 3 a) Temperature distribution during the welding process. The shadow zone corresponds with the liquid state of the soldering [12]**

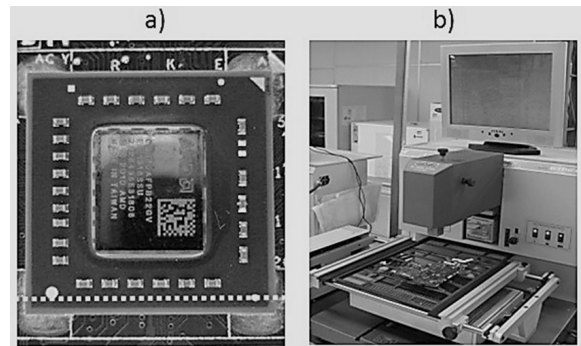
This research was developed according to the study of the process of welding in the change of components of BGA technology, evaluating the quality of the welding. This activity is inserted in the process of production of Notebooks. The assembly and welding of the component in the process of change of BGA were accomplished by a Station of Change of BGA operated by technicians of repairing area of the company. The Figure 4 shows the component BGA and the Station of Change of BGA.

**Figure 4 View of the BGA component and the device used for assembling and welding it. a) BGA Component; b) Station of assembling and welding the BGA Component. (Data organized by the author (2014))**

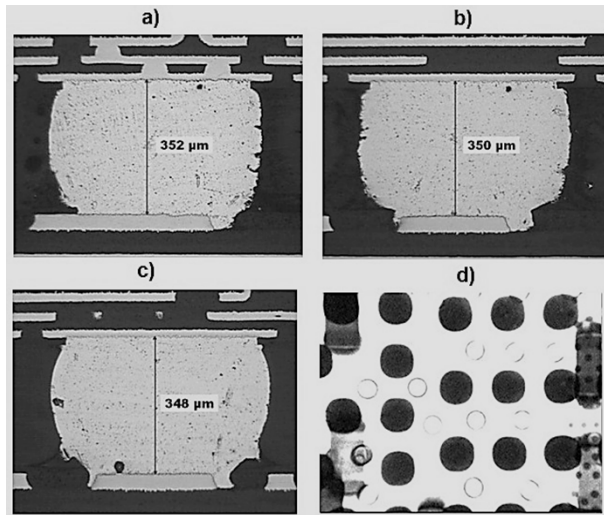
From the identification of the BGA component for the analysis, a study to evaluate the welding of the component was carried out. As described in the methodology, the *Cross-section* and the X-Ray of the BGA were used as evaluation methods. The *Cross-section* test was carried out in an external certified laboratory of analysis, the data obtained for the BGA component from this test are presented in Figure 5.

**Figure 5** Zoom of the Cross Section and X-Ray of the BGA Component a) Sphere of the left corner b) Sphere of the right corner and c) Center Sphere d) Partial area of all the spheres. (Data organized by the author (2014))

Figure 5 shows the obtained images with a zoom 100X by means of an optical microscope of the cut of the BGA Ball of the left corner (a), right corner (b), Center Ball (c) and of the X-Ray carried out for identifying Voids (d).

Analyzing the results of Figure 5 according to the requirements of the IPC A-610E and IPC-7095B it is possible to evidence that:

On the basis of the analysis of the results presented in Figure 5, it is possible to affirm that the company could perform the exchange process of a BGA component, inserted in the process of manufacture of notebooks, without risk in the final quality of the product, because the study of *cross-section* carried out in the BGA demonstrated that the executed process of welding attend the criteria of acceptability of International Standards IPC-A-610E and IPC-7095B, therefore, it can be concluded that there is quality in the welding process of the exchange of the component of BGA technology.

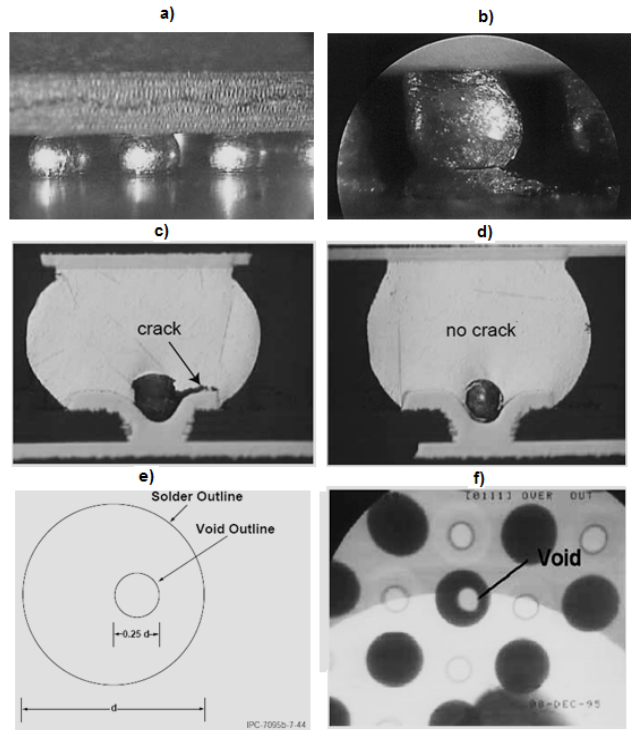
The positioning of the BGA *solder ball* is centered and does not show any displacement of the Ball for the land centers [14] Figure 6a shows an image of the alignment of the Ball according to IPC A-610E.

Figure 6 shows the crack of one ball specified by the IPC A-610E, a crack of a ball and a ball without crack according to the IPC-7095B.

The IPC-7095B [15] offers information about voids in BGA, including its sources, impact, detection and elimination, establishing a limit of up to 25% of the area of the *Ball*. Voids of great areas can produce reliability problems, because a reduced transversal section of the weld area has minor heat transfer, less mechanical load capacity, and less capacity of electrical current transport [23]. Figure 6 shows criterions for Voids according to IPC-7095.

**Figure 6** Images from the IPC standard for the criteria of acceptability: a) Alignment; b) Crack IPC A-610E; c) Crack IPC-7095B; d) No Cracks IPC-7095B; e) Acceptability of Void and f) Example of Void

Taking into account the data (i-iii) verified in the *cross-section* analysis of the BGA component according to the criteria of acceptability presented in Figure 6, it is possible to affirm that the weld joint analyzed was found in compliance with the Standards IPC-A-610 and IPC-7095B, therefore, it can be said that the process of welding in the BGA exchange fulfills the international concepts of quality. The costs involved for the company in the case of exchange of BGA components are referring to the manpower (including the orders) and replacement of the component. The cost with manpower in the studied period was of \$3,260.73, considering the annual production, the value would be of approximately \$26,085.88. The cost with replacement of the component was of \$1,371.18 (\$7.75/component). In the studied period and considering the annual production, the value would be \$10,925.98. These costs considering the exchange of the component are presented in Table 2:
