Hidroituango intake gate closure - Emergency conditions

ABSTRACT: This article presents the investigation, analysis, and results of the intake gate closure of two vertical fixed-wheel gates at the hydroelectric project Ituango in Colombia (2400 MW) under free-flow conditions. This atypical operation was considered successful notwithstanding adverse conditions, and therefore, it can be classified as a unique operation in the field of hydraulic gates. In this article, some relevant parameters, such as the hydraulic force of the servomotor during the operation of the gate, were measured before and after the operation and analyzed, and the results were presented. A new chart is proposed for the downpull coefficient based on the collected data, which could be implemented in the closure of gates against the free flow. Considering the abovementioned factors, the authors propose some recommendations and present drawn conclusions contributing to state of the art on design, manufacturing, and operation of this type of hydraulic gates and structures for large and small dams under adverse and extreme conditions.

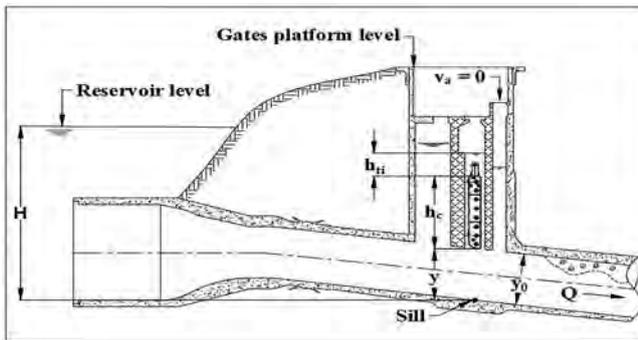
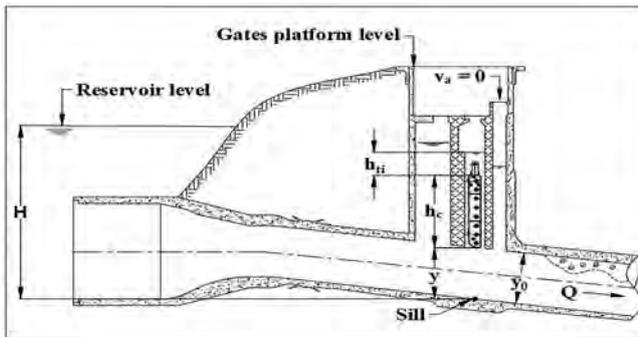
Figure 7 Hydraulic conditions before the closure

(a) Hydraulic conditions before the closure (a)

(b) Hydraulic conditions before the closure (b)

Where K^* : coefficient of downpull proposed by Suarez and Vera = 1.5 Finally, Figure 7. shows the hydraulic progression during the closure of the gate.

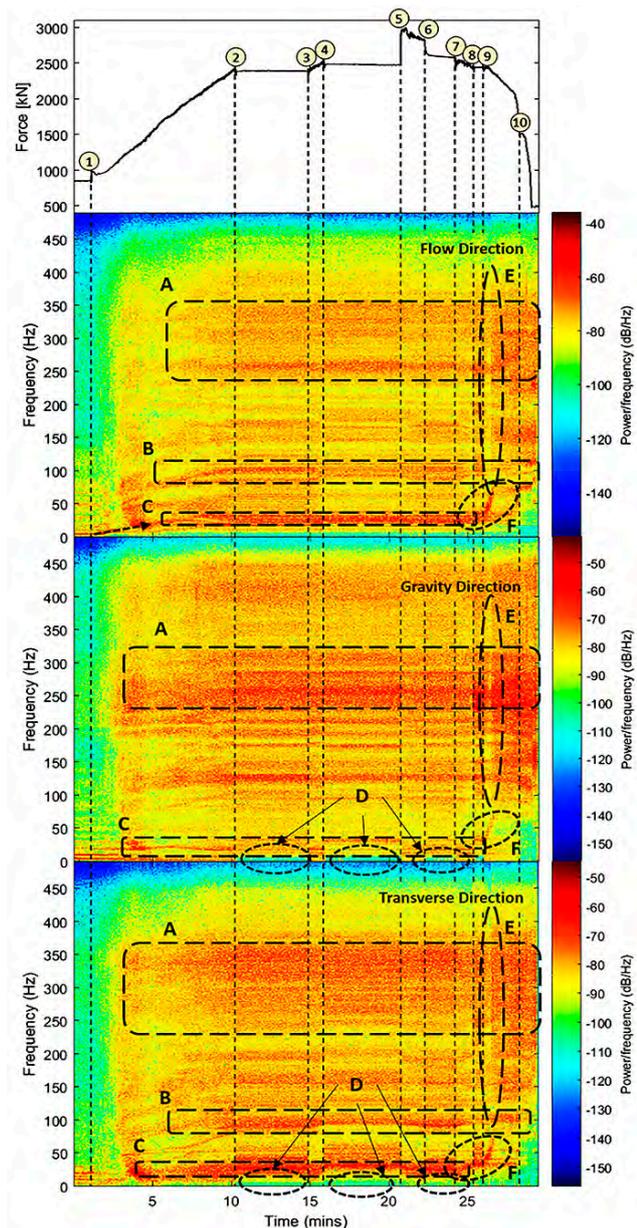
Figure 11 Spectrogram of the closure of the gate

Figure 11. shows a frequency analysis of the sampled forces in the gate N°2. Numerical marks included in the figure correspond to:

1. Start of the closure of the gate.
2. At 9.1min, the gate was at 61% of the closure, and it was necessary to stop the operation because the connection between the pressure wells 1 and 2 was noticed, i.e., a huge rock hollow has been created between both wells.
3. At 13.5 min, the decision was made to continue with the closure despite the connection between the pressure wells.

4. At 14.9 min, the gate was at 71% of the closure; the operation was stopped again due to the interference between the hoisting system of steel cables and the servomotor of the gate.

5. At 19.4 min, the decision was made to open the gate by 30 cm to solve this interference.
6. At 21.2 min, the gate returns to 66% of the closure. The hoisting system of steel cables was positioned in front of the servomotor of the gate.

7. At 23.1 min, the closure operation was restarted again.
8. At 24.3 min, the gate was in 77% of the closure, and it was necessary to stop the operation again due to strong transients and trepidation in the aeration well of gate N°2, which produced the sudden change in the flow direction of the air, expelling air with earth and rocks and water coming from the connection between the pressure wells and the rock hollow.

9. At 25 min, it was decided to continue the closure operation.
10. At 27.2 min, the gate was in 97% of the closure, but a strange behavior of the gate occurred due to interference between the steel cables and the lintel of the gate.

The alphabetical marks shown in the figure show a selection of inferences associated with the hydraulic phenomena presented during the closure operation, based on the data obtained by the instrumentation system installed in gate N°2:

- A. A range of frequencies between 230 and 350 Hz was noted, which are related to some harmonic modes of vibration of the gate structure. These can be estimated by hydrodynamic phenomena. This behavior developed from the moment the gate contacted the surface of the flow and remained constant until the complete closure.
- B. An exciting frequency is observed below 100 Hz, which conforms with the adhered mass of water (see mode 4 in Table 2).
- C. The excitation of a frequency near 29 Hz was observed, which concurs with the natural frequency of the servomotor beam (see in Table 5). This frequency showed a change when the gate first gets in contact with the free surface of the flow (backflow) due to the shift in the adhered mass.

- D. It was observed that when the gate was stopping (see point 3 indicated in the figure), frequencies below 10 Hz have disappeared. These frequencies appear to be caused by other vibrating modes similar to the produced by the movement of the gate seals in contact with its seal plate.
- E. A slight attenuation of the vibrations was observed in 97% of the closure, due to the subsequent effect of the transient occurred in the aeration well N°2 (see marks 8 and 9) and the impact that produced the entry of air from the well N°1 through the rock hollow.
- F. An increase of the frequency is indicated in Table 2, and it was observed due to the decrease of the mass adhered during the approach of 100% of the closure and due to the interference between the steel cables and the lintel of the gate.
